# **Stonybrook Creek Fish Passage Assessment**

**Alameda County  
Public Works Agency**

**MICHAEL LOVE**

**APRIL 6, 2001**

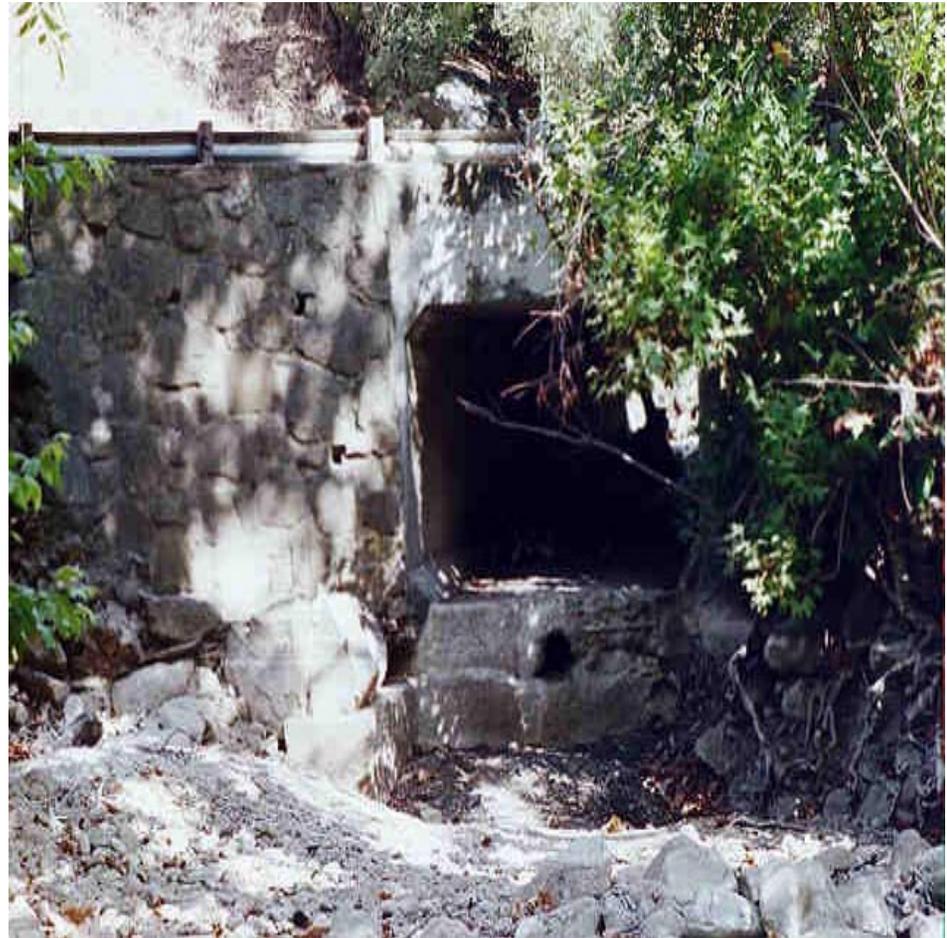
## Stobk#1: Highway 84 (Niles Canyon Road), milepost 12.90

The road-crossing on Highway 84 lies at the confluence of Stonybrook Creek with Alameda Creek and is maintained by the California Department of Transportation (CalTrans). Currently, the road-crossing fails to meet passage criteria at all flows. Steelhead are known to have successfully negotiate this culvert under limited flow conditions. Action should be taken to ensure this crossing does not impede migration of steelhead. Additionally, providing access for juvenile and resident steelhead/rainbow trout to Stonybrook Creek should be considered when selecting an alternative due to the cold water refugia the stream provides during summer months.

Replacement of the existing concrete box culvert with a bridge or open-bottom arch spanning the active channel (approximately 20-feet) combined with removing deposited sediment and regrading the upstream channel bed to its natural slope will allow for unimpeded passage of all salmonid lifestages and the efficient transport of stream bed material through the crossing.

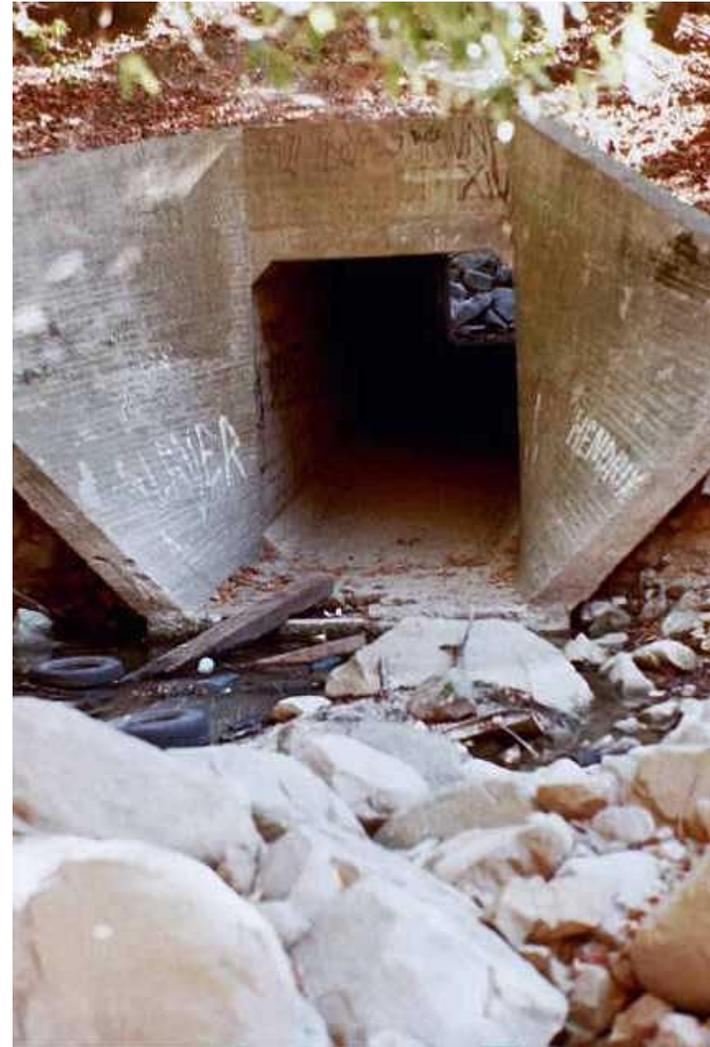
## Stobk#2: Palomares Road, milepost 8.75

The furthest most downstream culvert on Palomares Road is Stobk#2. It is a total barrier based on both the analyses performed as part of this inventory and direct observations made in 1999 (Alexander, 1999). The existing concrete box culvert is undersized, which has caused upstream ponding of water, extreme channel aggradation, and the creation of an 11-foot drop in the channel bed at the inlet. Full replacement of this road-crossing is the only feasible option for providing fish passage.

A pre-fabricated concrete arch placed on concrete footings may be the most suitable replacement structure. Due to the height of the road above the existing crossing, replacement with a bridge would require an extremely long span and likely be cost-prohibited. The new crossing should have a span of at least 20-foot to allow unimpeded transport of bedload, comprised primarily of boulders. To eliminate the 11-foot drop above the existing culvert inlet, the stream should be recontoured at an average channel slope of approximately 8.5%. Although the channel would be relatively steep, using an open bottom arch containing natural boulder substrate should encourage the formation of pools throughout the reach and create suitable fish passage and habitat conditions.

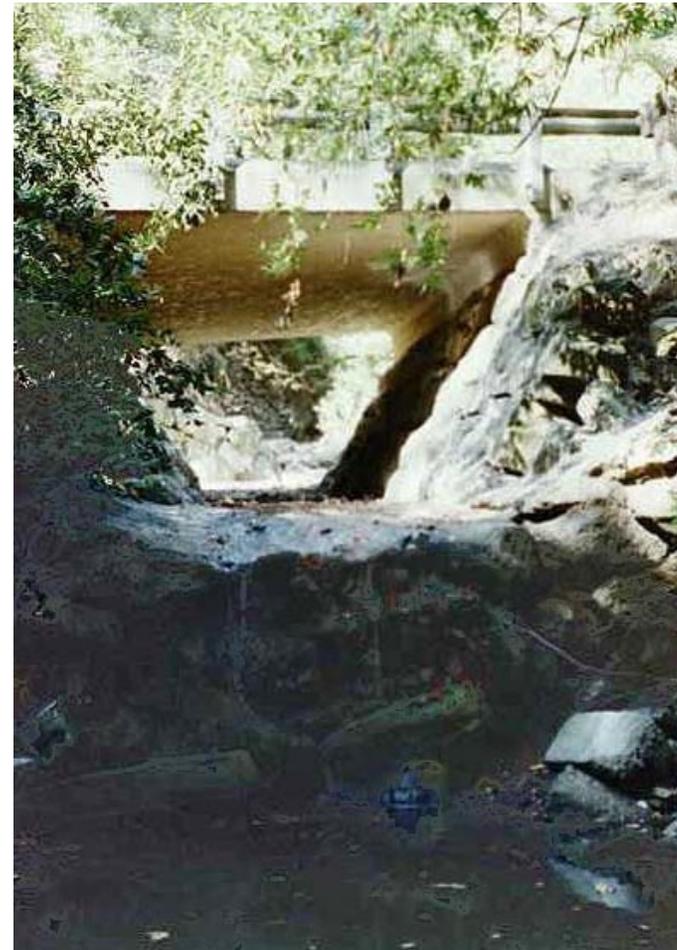
### Stobk#3: Palomares Road, milepost 8.60

The road-crossing at milepost 8.60 is extremely undersized, causing scour of the downstream channel through excessive outlet water velocities at high flows. As a result the channel has locally degraded approximately 5-feet at the culvert outlet. The most suitable solution for eliminating the fish passage barrier is full replacement of the crossing with a bridge or open bottom arch with a span of approximately 20-feet.

**Drop into Pool at Crossing Outlet**

Because Stobk#3 through Stobk#8 are historic structures constructed in the 1930's, replacement may be difficult. For Stobk#3, an interim solution may be installing a fishway at the culvert outlet combined with fish weirs within the crossing to provide for upstream passage of adult steelhead and possibly larger rainbow trout. A steep-pass or denial fish ladder leading from the outlet pool to the apron could be mounted onto the bedrock wall along the left side of the channel. Weirs would need to be installed throughout the crossing to provide adequate water depth and reduced velocities. As part of the retrofit, the existing floor throughout the crossing should be relined with concrete and a headwall installed below the outlet apron.

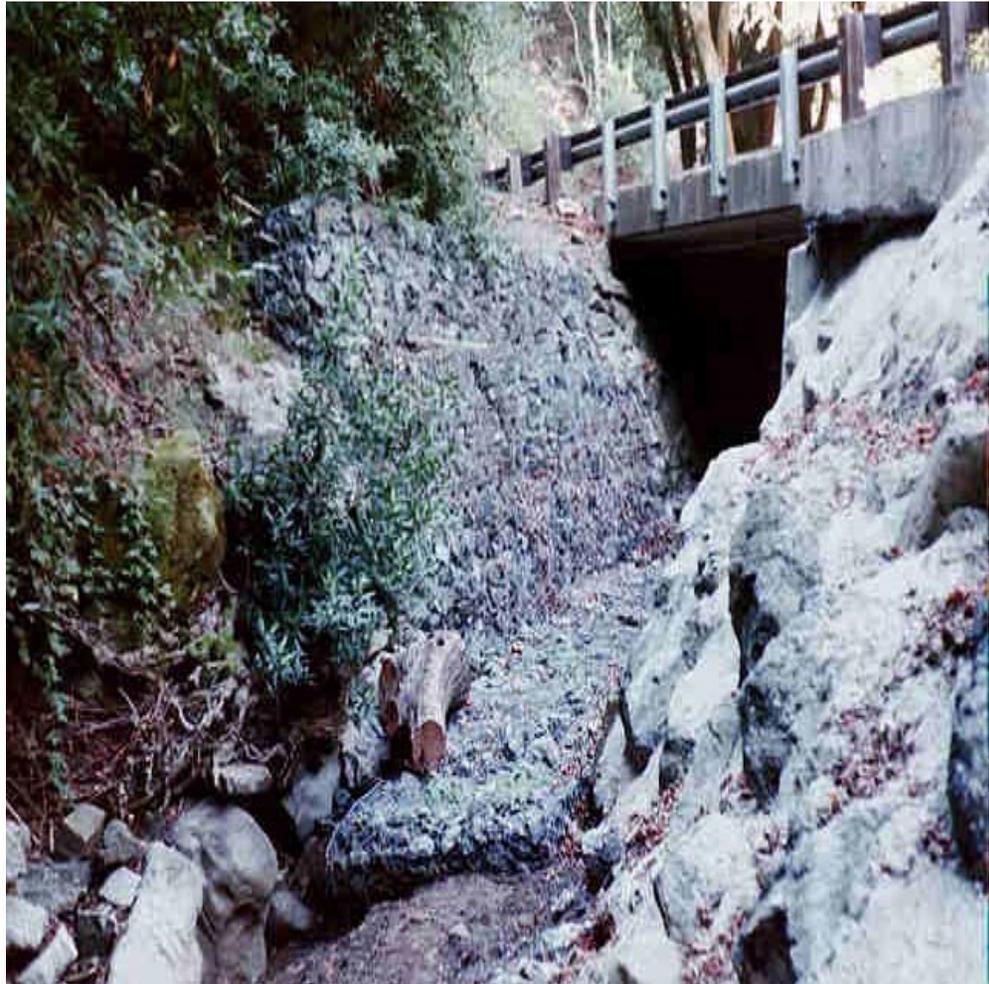
## Stobk#4: Palomares Road, milepost 8.16

The outlet apron on Stobk#4 has recently been rebuilt with a gabion floor and retaining wall. The gabion floor has already failed in several locations and creates an upstream migration barrier to all fish due to its steepness (greater than 6%). Alternatives for achieving passage of steelhead and large rainbow trout at Stobk#4 could involve replacing the gabion floor with concrete and installing a series of weirs throughout the entire crossing.

**Outlet of Road-Crossing with Gabions**

between the two crossings, they should be considered for barrier remediation at the same time. The preferred option for providing fish passage at both of these road-crossings is to replace them with bridges or open bottom arches spanning the active channel.

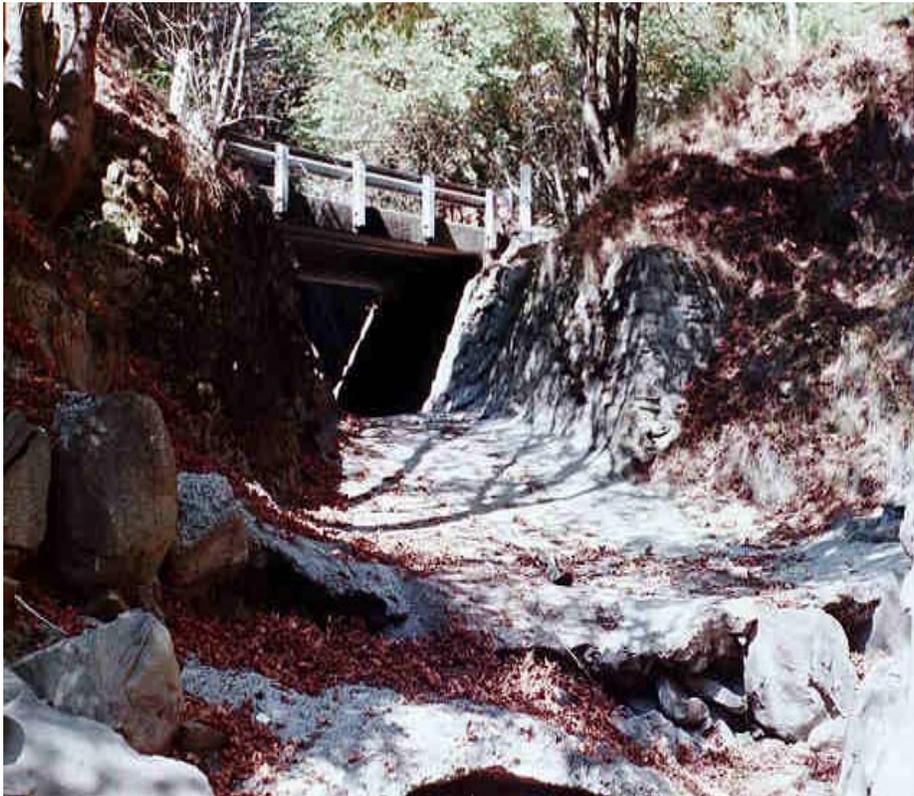
## Stobk#5: Palomares Road, milepost 8.00

**Outlet Apron**

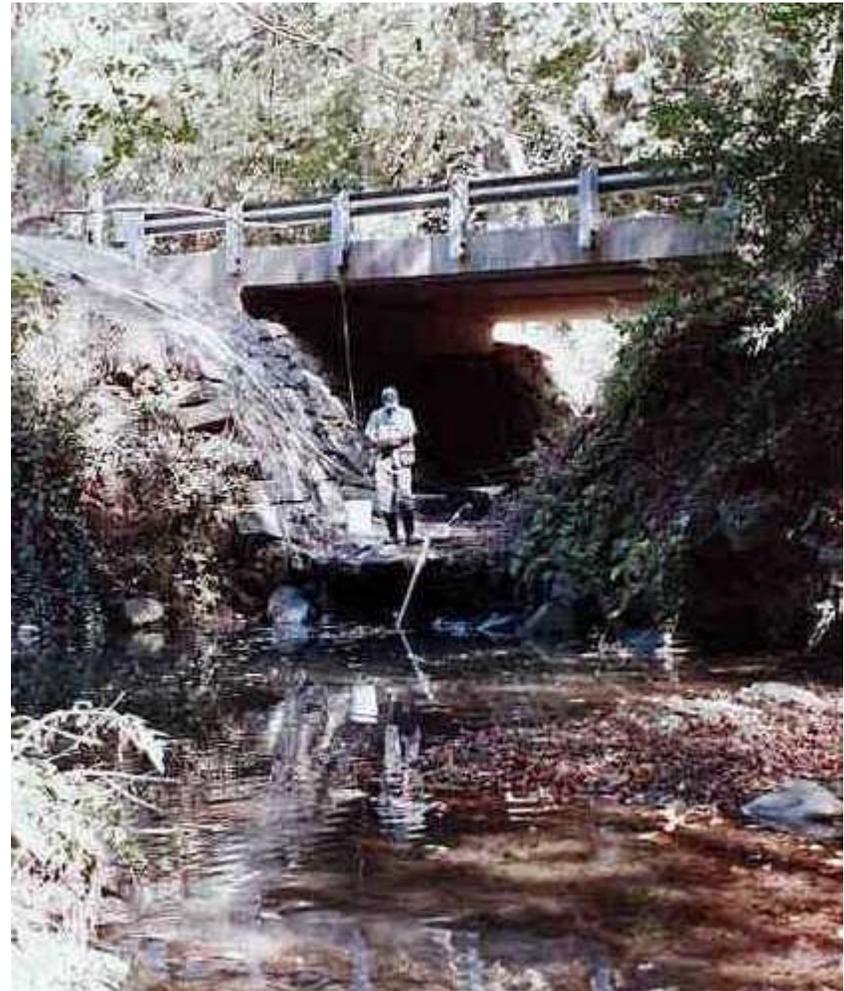
## Stobk#6: Palomares Road, milepost 7.57

Currently Stobk#6 does not meet adult and juvenile fish passage criteria but at higher flows some steelhead would likely be able to negotiate the outlet drop and shallow water depths. Moderate modifications to the crossing could create suitable passage conditions for both adult and juvenile steelhead/rainbow trout, opening up access to potentially 7,000-feet of upstream habitat.

**Drop at outlet into pool**

Installation of three boulder weirs downstream of the crossing would raise the tailwater approximately two feet, eliminating the perched outlet. Placement of a one foot high notched beam on the edge of the outlet apron combined with two to three additional baffles across the lower portion of the crossing could create suitable hydraulic conditions for adult and juvenile fish passage.

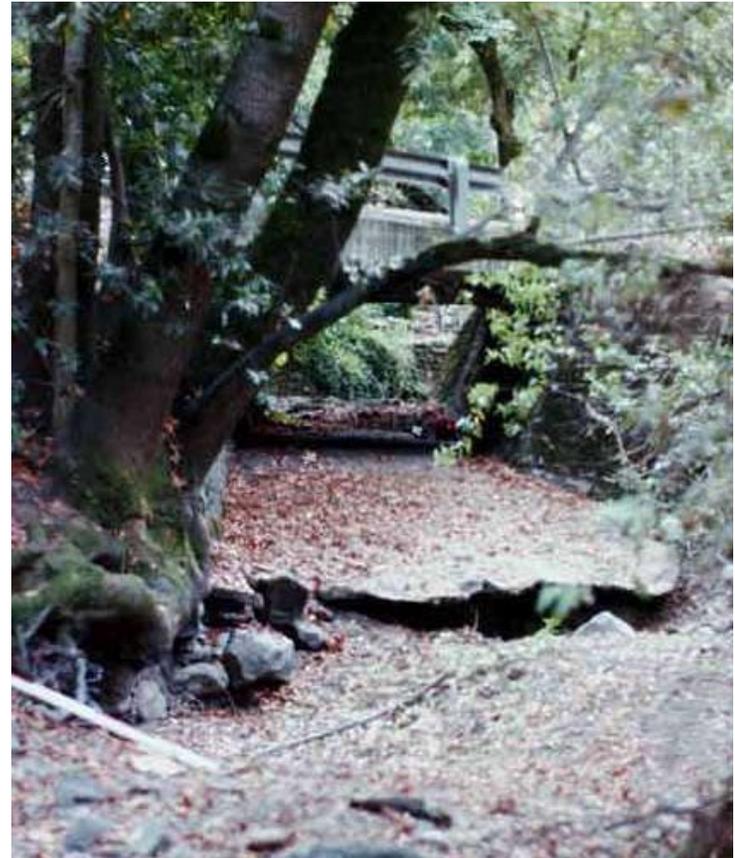
## Stobk#7: Palomares Road, milepost 6.28

Outlet Apron

downstream of the crossing would submerge the outlet apron and create suitable fish passage conditions. If downstream barriers are removed, retrofitting this crossing for fish passage could potentially provide access to the remaining 10,000-feet of upstream habitat.
