TECHNICAL MEMORANDUM

ASSESSMENT OF FISH UPSTREAM
MIGRATION AT NATURAL BARRIERS
IN THE UPPER ALAMEDA CREEK
SUB-WATERSHED

Prepared for
San Francisco Public Utilities Commission

January 2010

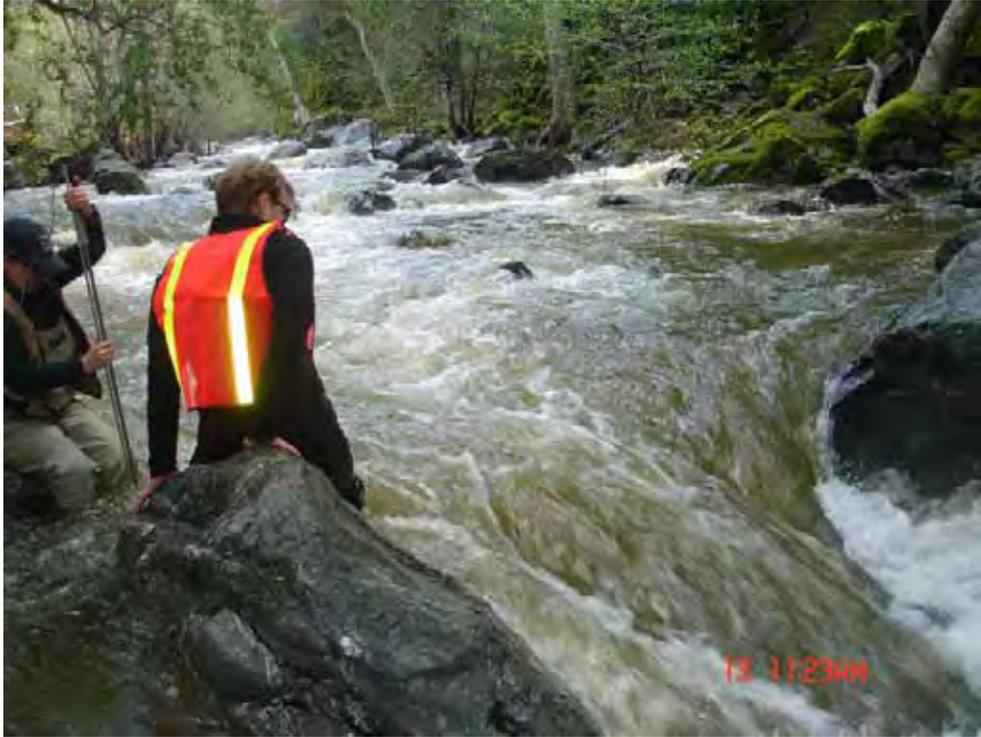
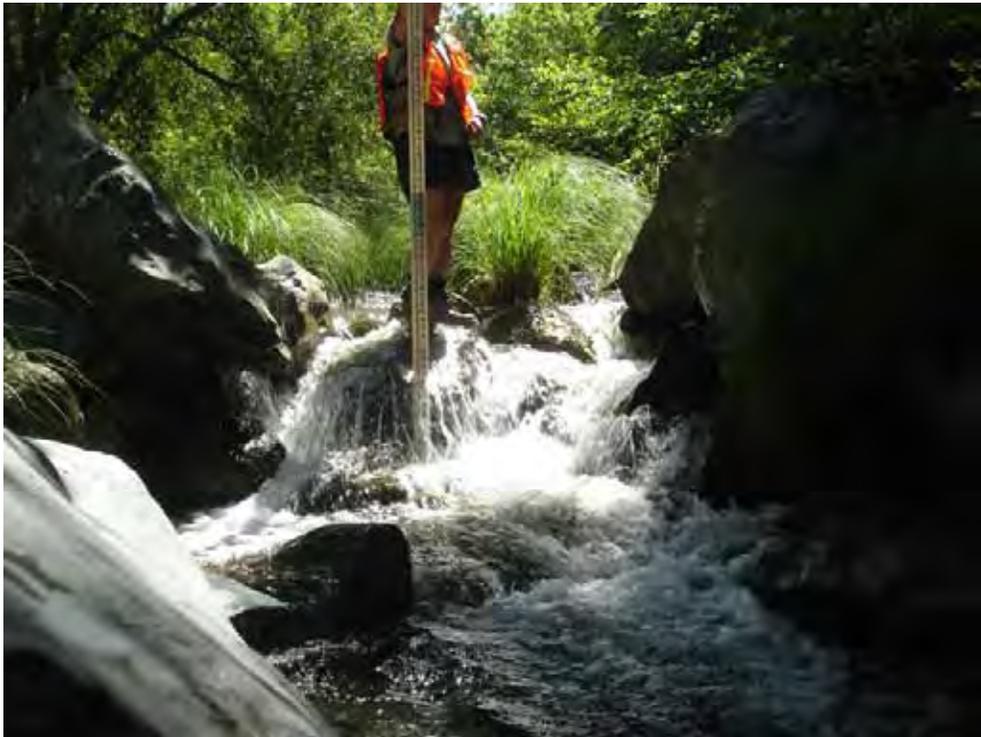
Photographs of Little Yosemite Feature 2
Assessment of Fish Upstream Migration at
Natural Barriers in the Upper Alameda Creek Sub-Watershed
Technical Memorandum

Example photographs of one (Feature 2) of the readily passable features (Features 1-8) evaluated in the Little Yosemite reach of Alameda Creek (a) on March 13 and (b) June 23, 2006.

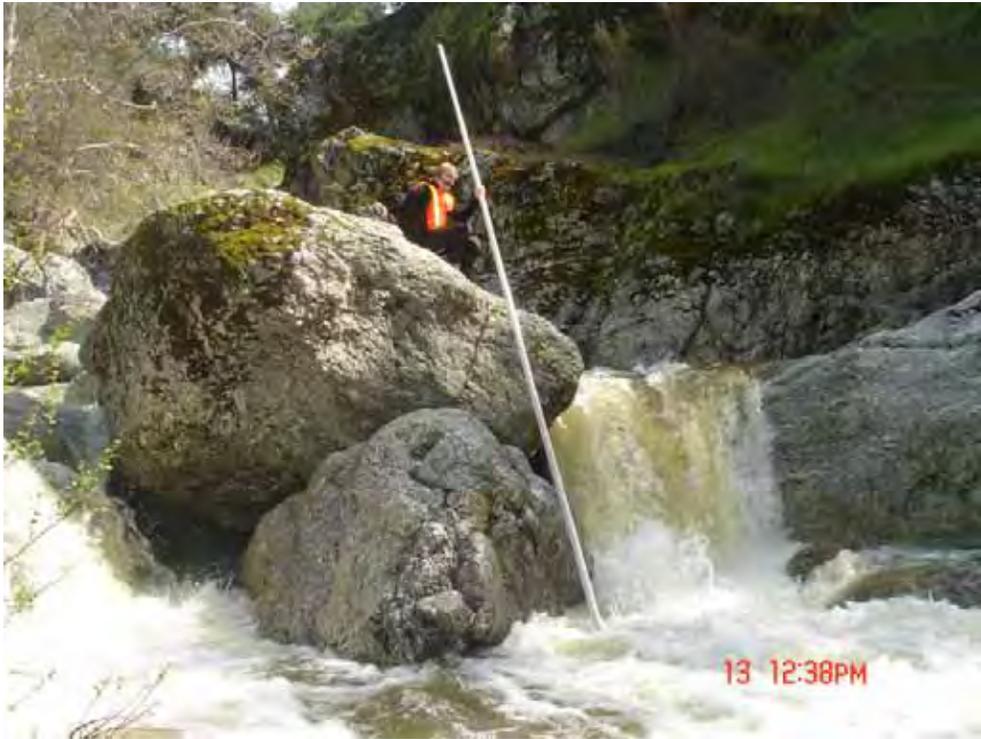
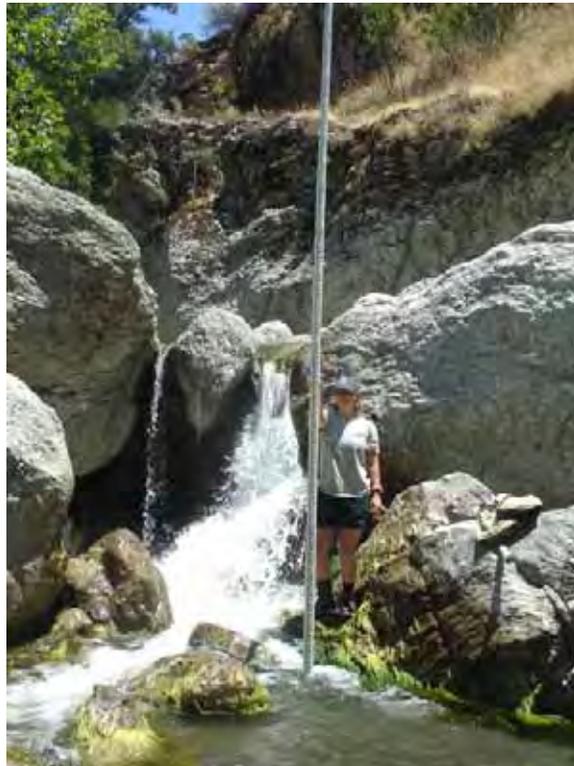
Photographs of Little Yosemite Feature 9
Assessment of Fish Upstream Migration at
Natural Barriers in the Upper Alameda Creek Sub-Watershed
Technical Memorandum

Photographs of Feature 9 in the Little Yosemite reach of Alameda Creek, on (a) March 13 and (b) June 23, 2006.

On March 13, 2006, with daily average flow of 98 cfs, flow at Feature 9 was observed to be split by a boulder in the middle of the channel (Figure 4-5 [a]). Passage was visually estimated as impossible at that time. Potential passage routes through spaces between submerged boulders could have been obscured, however, and quantitative measurements of those features could not be obtained due to high flows. Therefore, the passability of this feature was further evaluated during the low-flow field assessment on June 23 before a conclusion regarding its passability could be reached.

At both flows assessed in this memorandum, Feature 9 was determined to be an impassable elevation barrier to steelhead in good condition (and a horizontal distance barrier to steelhead in bright condition). This result is explained below.

In summary, Feature 9 is determined to be impassable by bright steelhead during a flow of 2.5 cfs due to both its vertical height and horizontal range (Figure 4-6). Feature 9 was also determined to be impassable to steelhead in good condition (the condition expected of steelhead potentially immigrating to this feature in the future). The estimated maximum leap height of an adult steelhead in good condition ($Cfc = 0.75$) in Alameda Creek is 6.1 feet. The distance of the takeoff point from the falls (12.0 feet) reduces the vertical component of the fish's leap due to the reduced angle (63.1°) that the fish must leave the water. This angle reduces the height of the leap from its optimal 6.1 feet to 4.8 feet, and limits the horizontal distance of the leap to 8.8 feet (Figure 4-6). It is assumed that these distances would not be sufficient to negotiate passage by steelhead in good condition at this feature with flows observed during either the March 13 or June 23 field assessment.

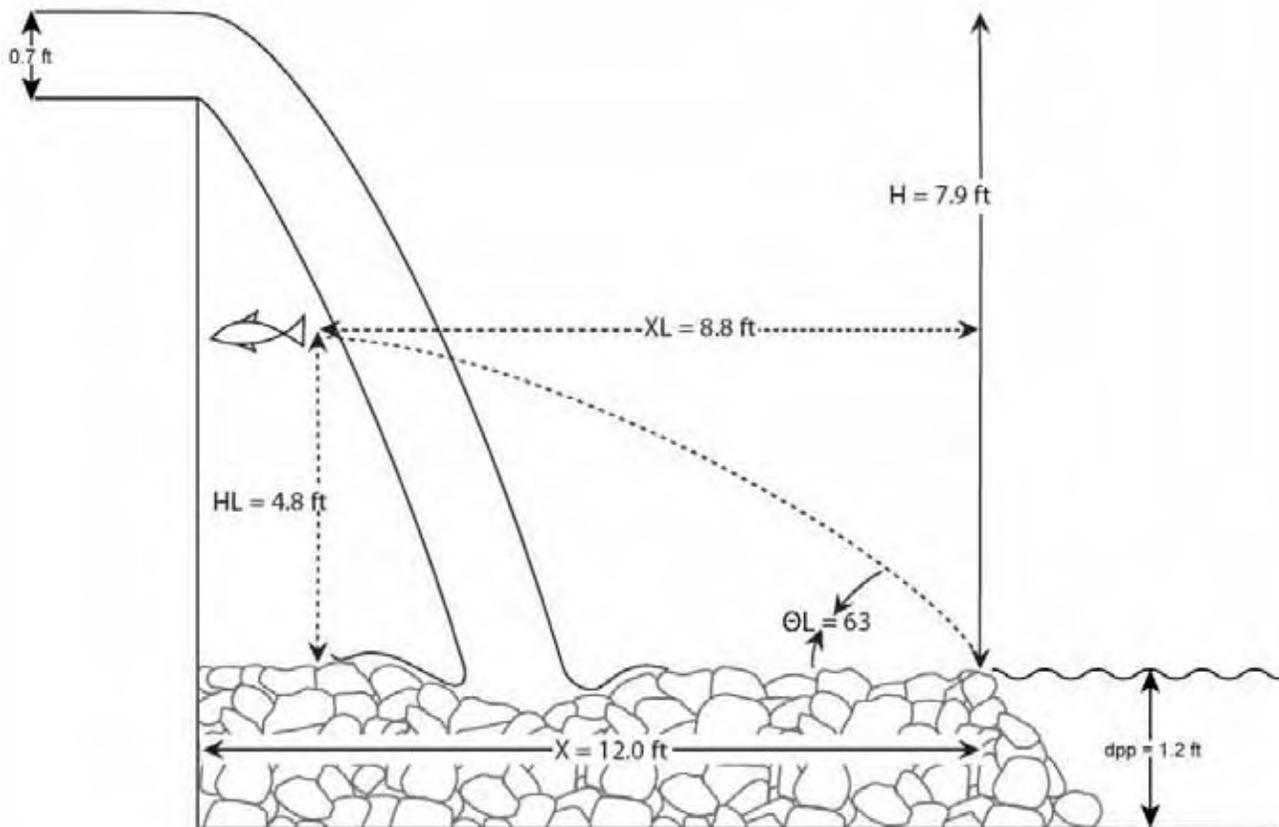
Figure 4-6 Cross Section of Little Yosemite Feature 9

Parameter	Data Notation	Measured Value (feet)
Vertical Height	H	7.9
Horizontal Width	X	12
Depth of Staging Pool	d_{pp}	1.2
Depth of Landing Site	d_c	0.7

Note: The average flow on the day of the field assessment was 2.5 cfs.

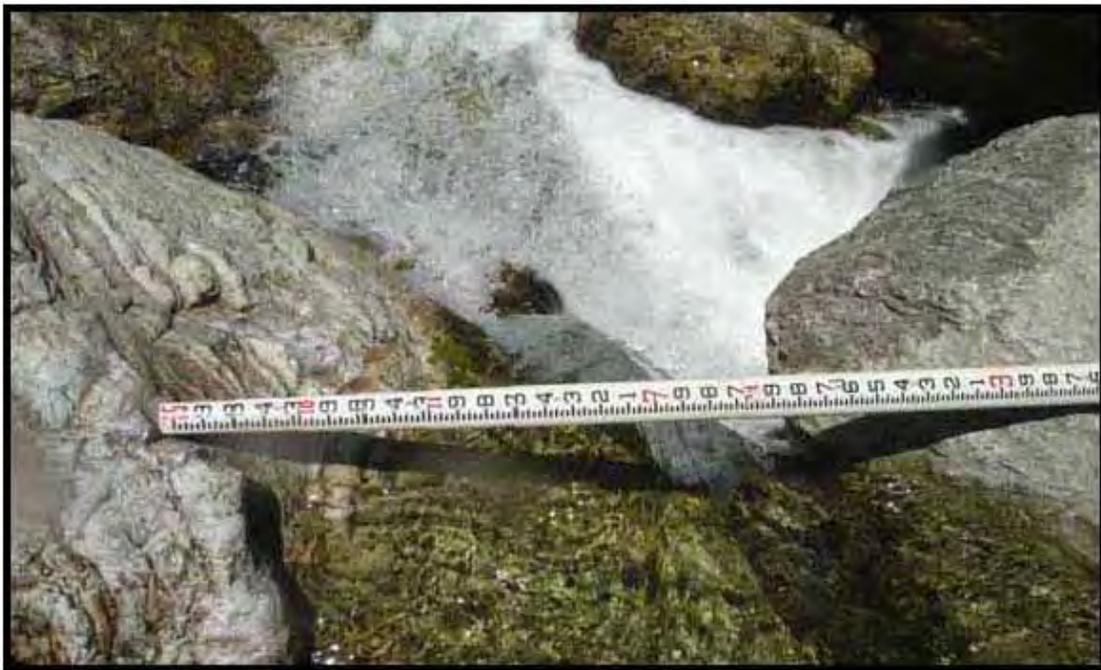
Figure 4-8 Landing Point of Little Yosemite Passage Feature 9

Finally, it is noted that the landing at the top of the falls (Figure 4-8) is a chute (with a water depth of approximately 8 inches during the lower-flow field assessment) that would require the fish to achieve an adequate burst speed to reach a velocity refuge located approximately 3 feet upstream of the landing point. Figure 4-8 is a photograph taken from the top of the feature looking nearly straight down to show the narrow landing conditions, approximately one-half foot wide, at the top of the falls. It is uncertain if an adult steelhead (even in “bright” condition, $C_{fc} = 1.00$) would be able to achieve the level of precision required to navigate through this chute while descending through the air. The velocity of the chute and the distance to a velocity refuge upstream were determined not to be a limiting factor in the passability of this feature. It is unknown whether this feature poses a barrier to upstream migration at flows higher than 98 cfs (Section 5.1).

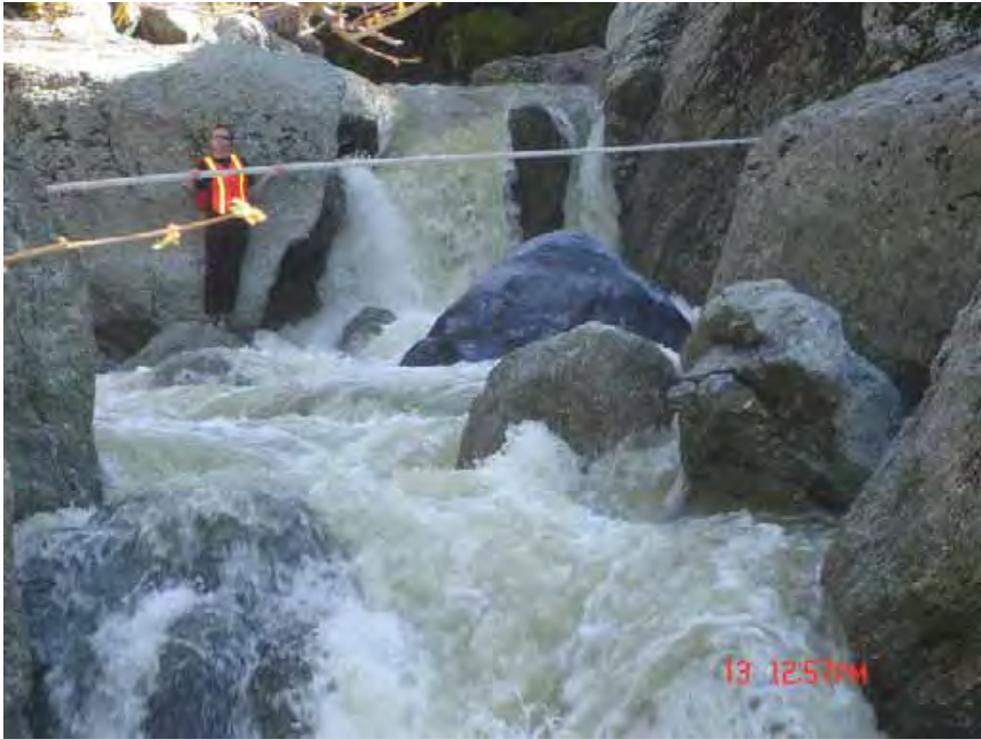
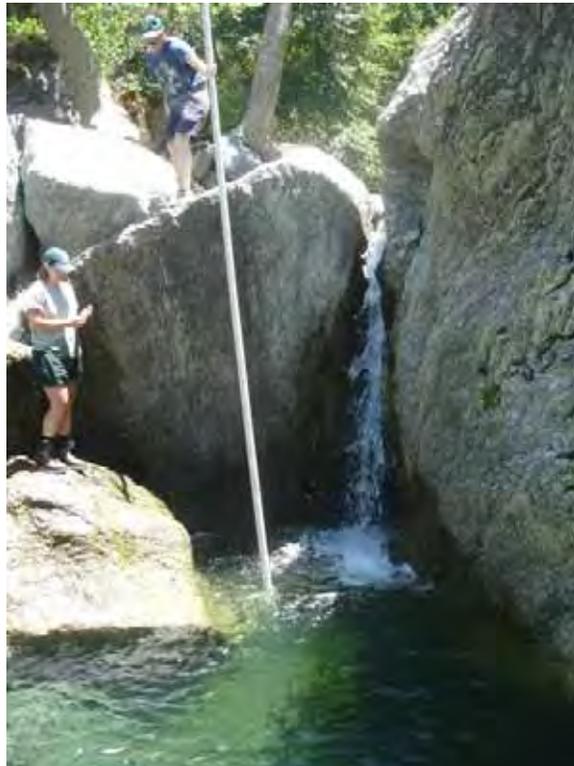
Photographs of Little Yosemite Feature 10

Photographs of Feature 10 in the Little Yosemite reach of Alameda Creek, on (a) March 13 and (b) June 23, 2006.

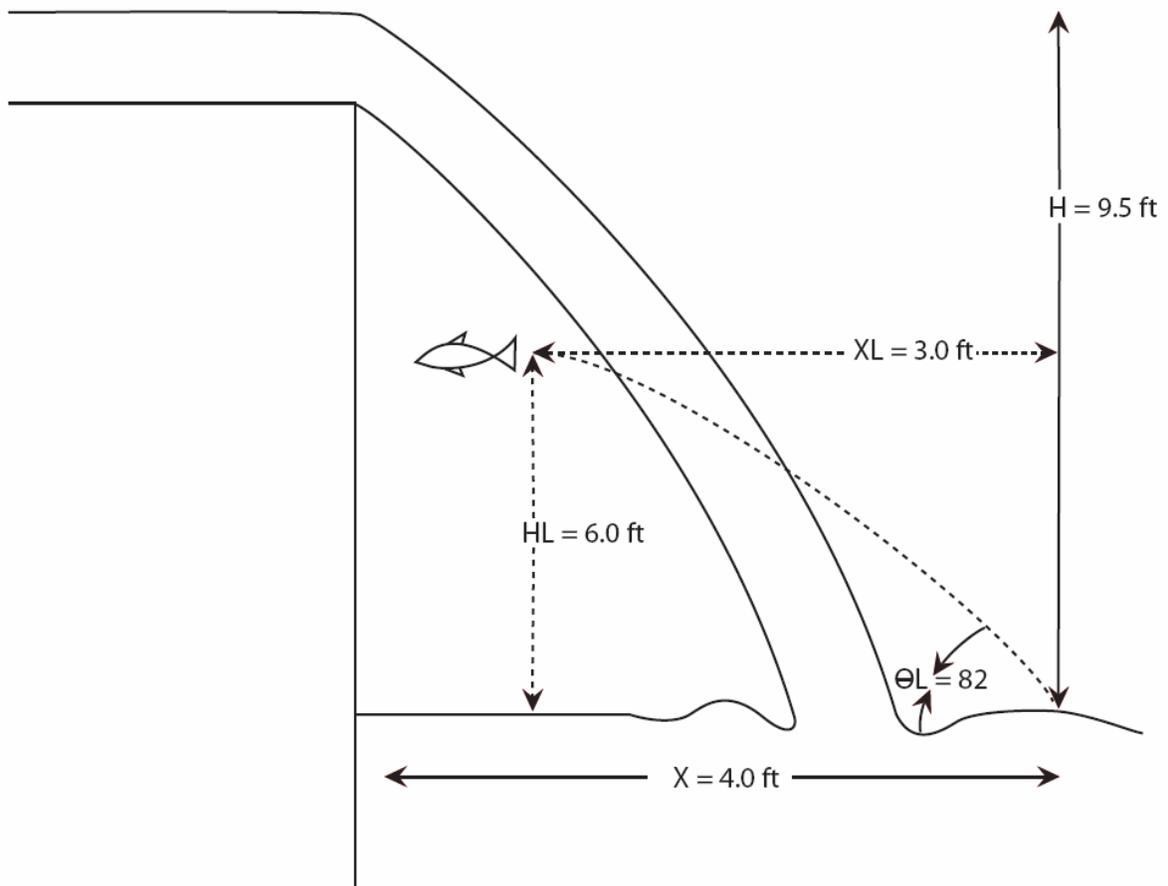
Figure 4-10 Cross Section of Little Yosemite Passage Feature 10

Parameter	Data Notation	Measured Value (feet)
Vertical Height	H	9.5
Horizontal Width	X	4
Depth of Staging Pool	d_{pp}	-
Depth of Landing Site	d_c	0.4

Note: The average flow on the day of the field assessment was 2.5 cfs.

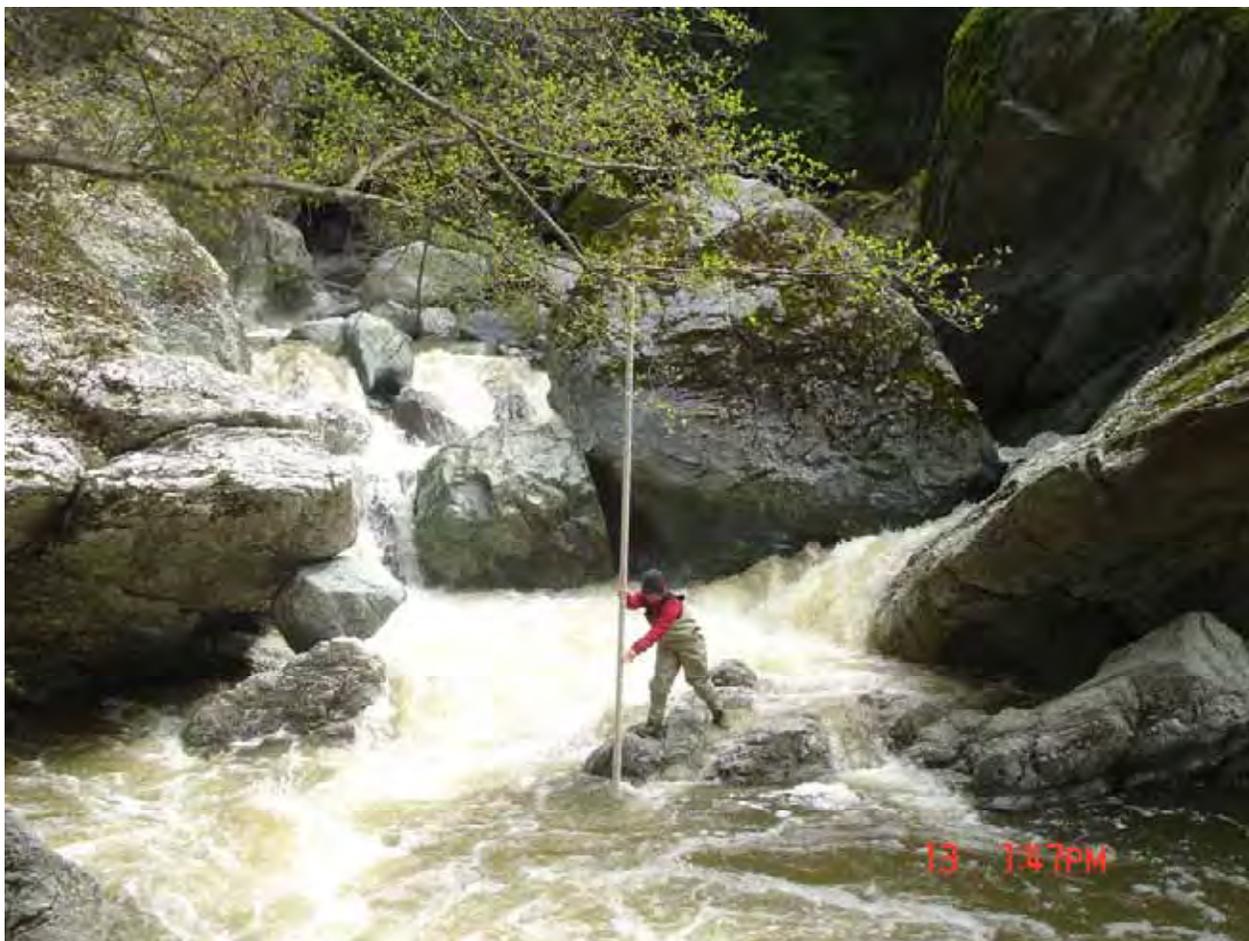
Figure 4-11 Little Yosemite Passage Feature 11

Note: The average flow on the day of the field assessment was 98 cfs.

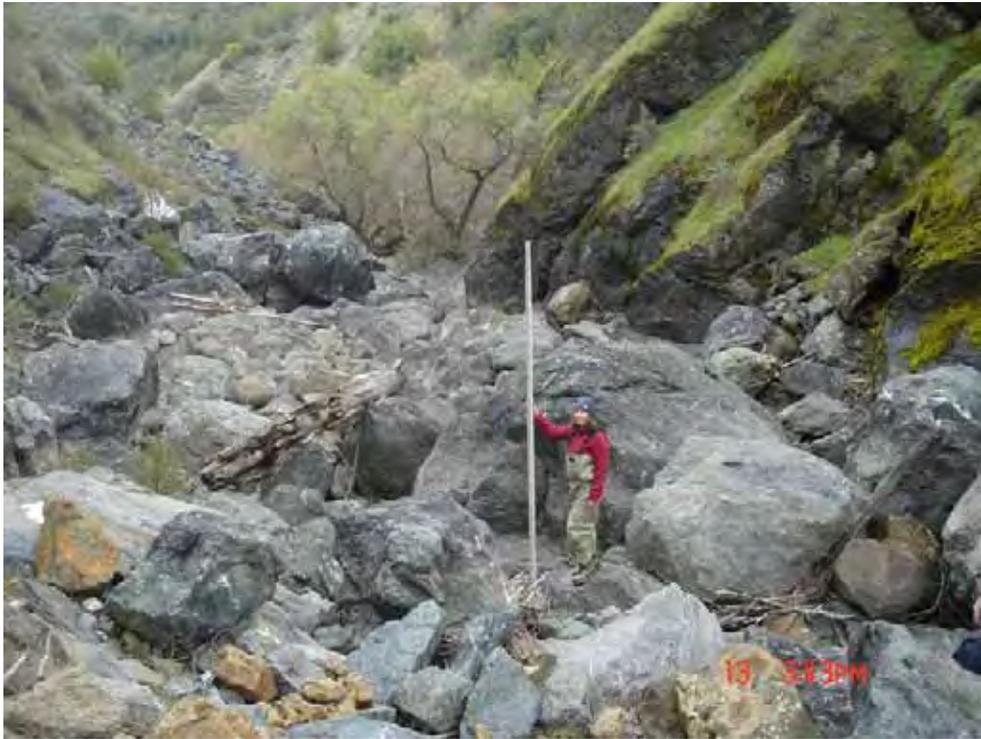
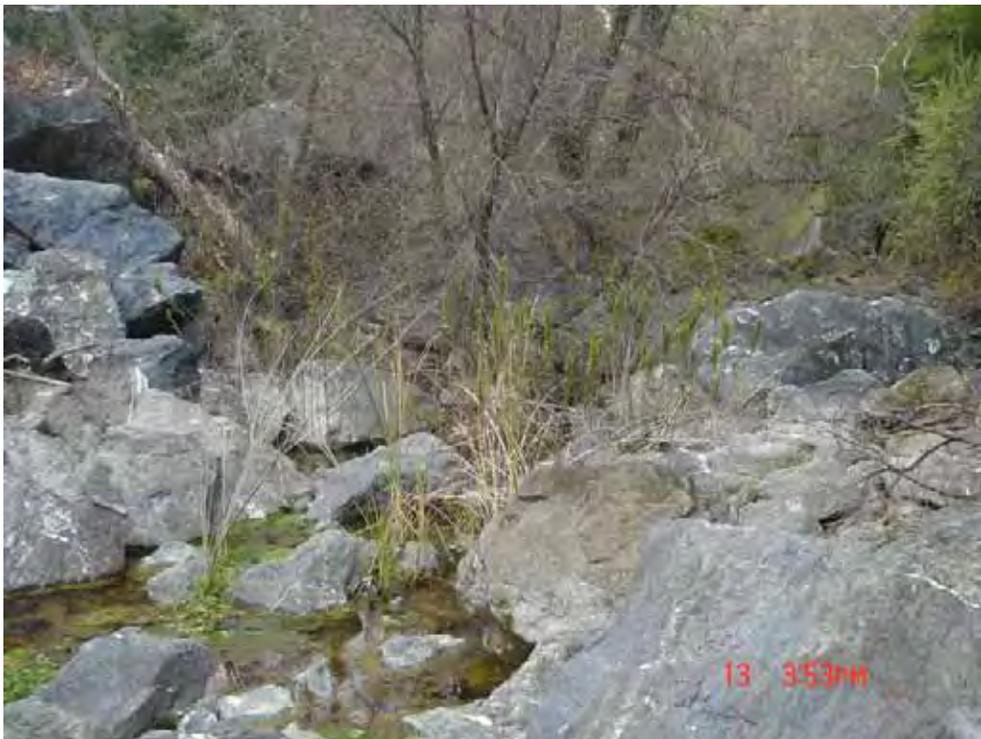
**Photographs of the
Calaveras Boulder Debris Field Reach**

Subsurface flows and high channel gradient (a), and low flows (b), in the Calaveras boulder debris field reach, March 13, 2006.

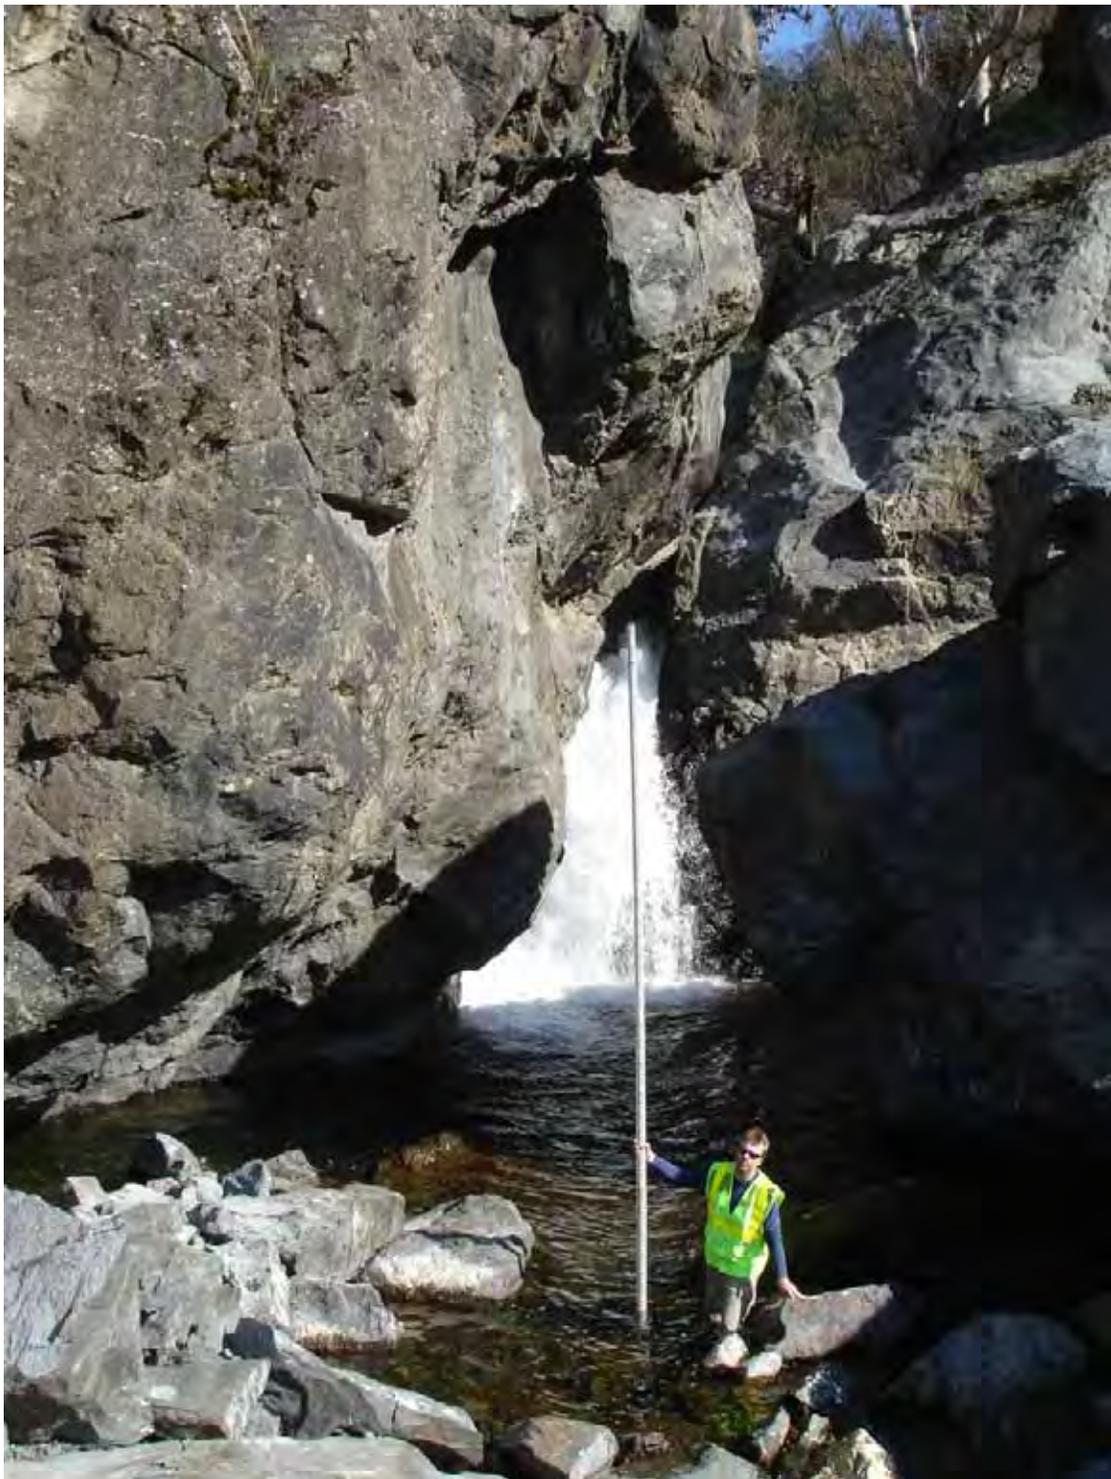
Waterfall on Arroyo Hondo

The water spills from upstream through a gap in the boulders at the apex of the barrier. The horizontal distance from the leap takeoff point immediately downstream of the standing wave to the landing location at the top of the falls is approximately 3 feet. Although the takeoff pool conditions are good with adequate run-up length and water depth, the falls flow comes from underneath a large accumulation of boulder debris lodged at the top of the falls. This rock overhang above the landing at the top of the falls creates a similar landing access problem as would occur with fish passage at a pipe culvert, where the success of a fish's leap would be limited by the lack of overhead clearance and shallow water depth at the landing site. Additionally, the landing at the top of the falls occurs at the bottom of the enclosed boulder debris chute, which creates an approximately 5-foot-long tunnel through the rock. A fish attempting to negotiate this feature would conceptually be leaping 15 feet up into a tunnel, against the hydraulic head created by water upstream. The water velocities in the tunnel could not be measured due to the enclosed nature of the feature, but if the vertical barrier height did not make the feature impassable, then the landing conditions and the velocity and turbulence of the water from the landing to a velocity refuge would likely make this feature impassable under all anticipated flow conditions.

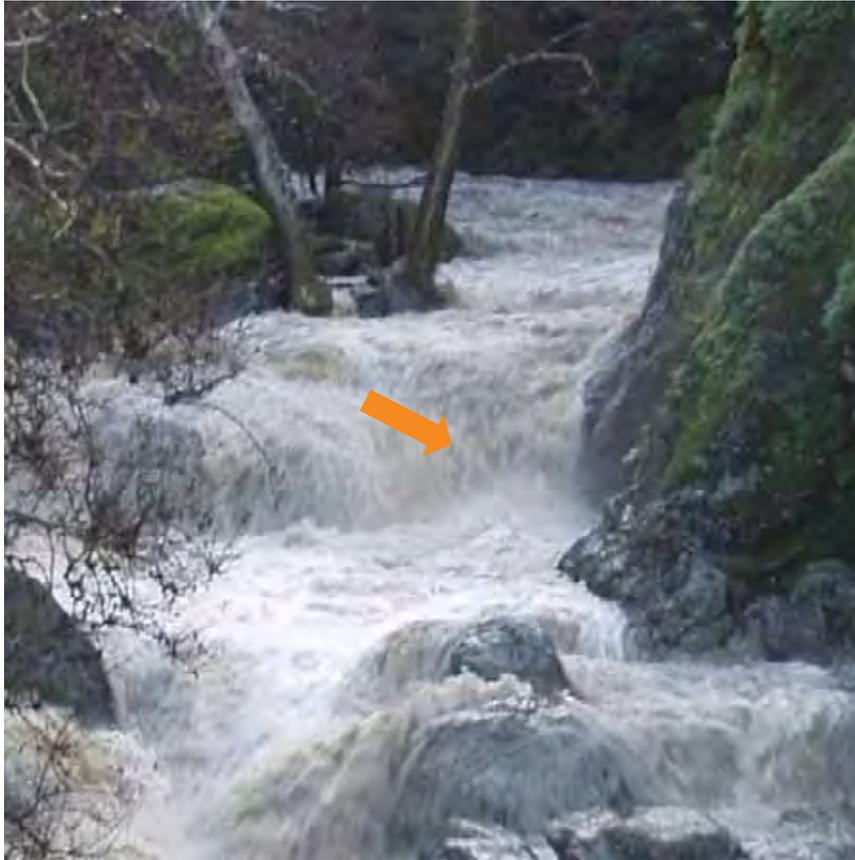
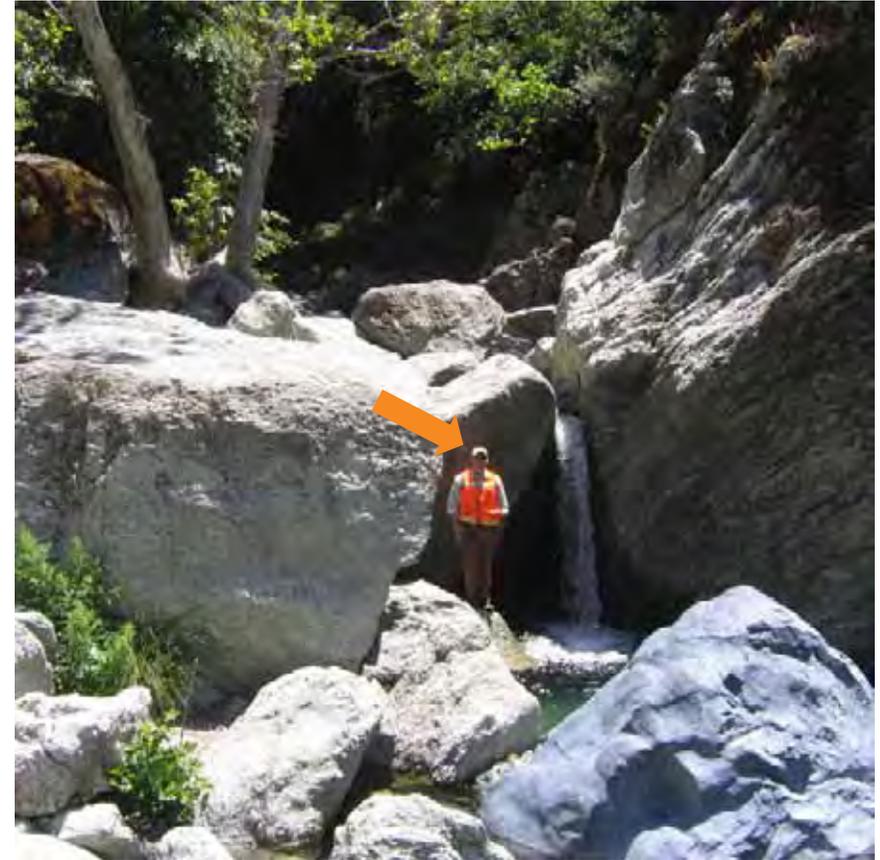
Little Yosemite Feature 10 at Low and High Flow

Feature 10 in the Little Yosemite reach of Alameda Creek, (a) on March 4, 2009 with flow of approximately 505 cfs and (b) on May 27, 2009 with flow of less than 1 cfs. The arrow identifies the same location in both photographs.

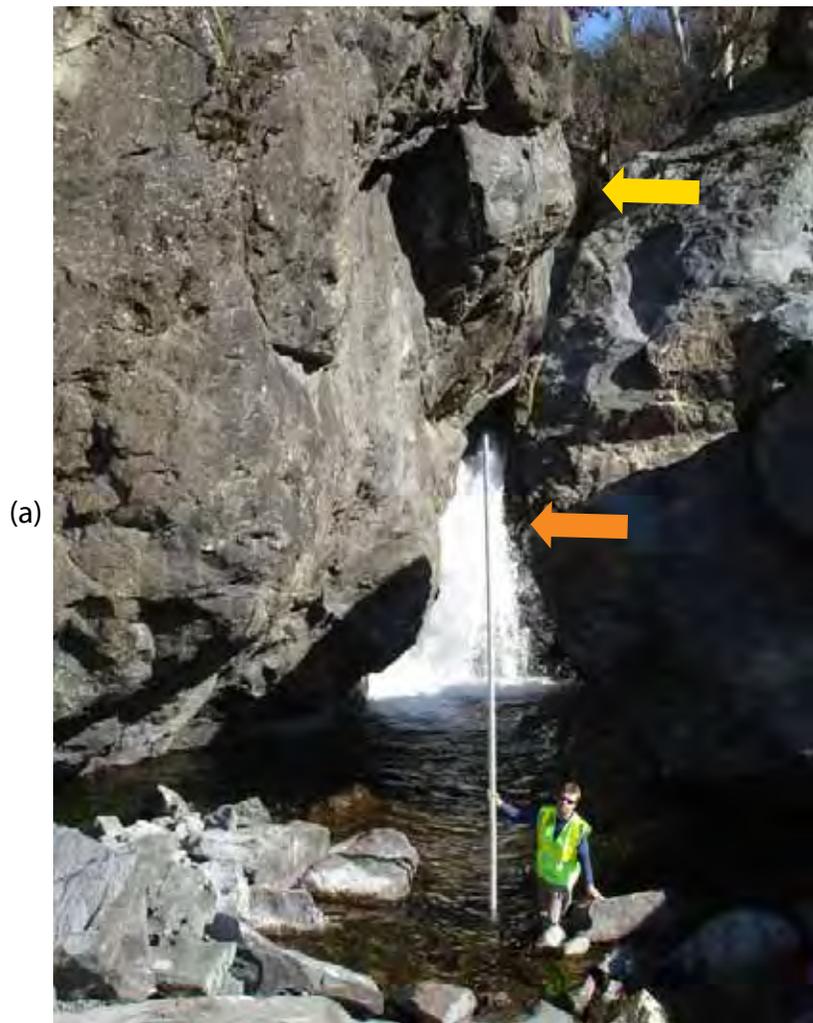
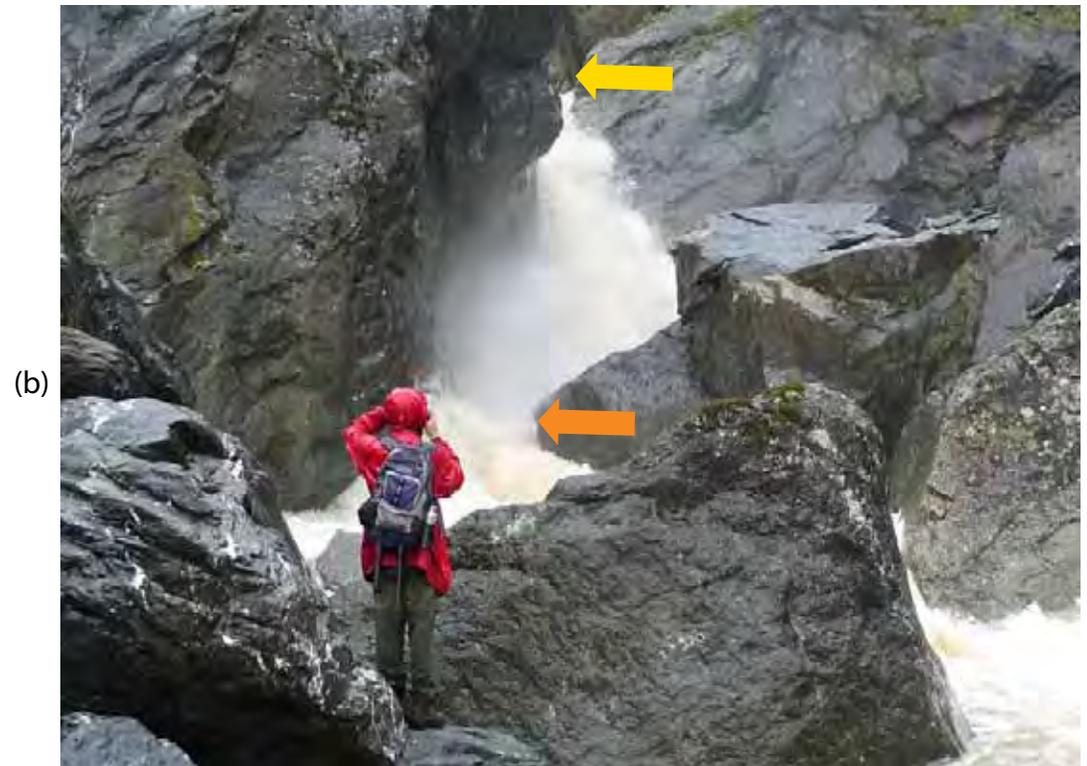
Waterfall on Arroyo Hondo at Low and High Flow
Assessment of Fish Upstream Migration at
Natural Barriers in the Upper Alameda Creek Sub-Watershed
Technical Memorandum

Fifteen-foot-high waterfall in the landslide reach of Arroyo Hondo, (a) on February 23, 2006 with flow of approximately 17 cfs, and (b) on March 3, 2009, with flow of approximately 590 cfs. The arrows identify the same locations in both photographs.

Because Arroyo Hondo is an unimpaired tributary, there is no way to influence flows for fish passage. Adult steelhead passage at the waterfall could potentially be facilitated either through direct physical modification or construction of a fish ladder. However, any attempt to facilitate fish passage at this barrier would require extensive geotechnical review due to the instability of the channel slopes (URS, 2009). The landslide on the north canyon wall includes clear evidence of ongoing slide activity and instability, including the toe of the slide immediately adjacent to the channel (Figure 3-6). Given the size of this landslide, as well as the presence of another landslide on the opposite steep canyon wall, channel modifications to facilitate fish passage at Arroyo Hondo would be challenging. Excavation near the north or south channel slopes has potential to destabilize the slides and accelerate their movement, and could require major engineered slope stabilization solutions. Additional investigation and analysis would be required to determine whether such modifications are feasible, or to what extent the slopes would need to be stabilized.
