# ASSESSMENT OF FISH UPSTREAM MIGRATION AT NATURAL BARRIERS IN THE UPPER ALAMEDA CREEK SUB-WATERSHED

Prepared for San Francisco Public Utilities Commission

January 2010

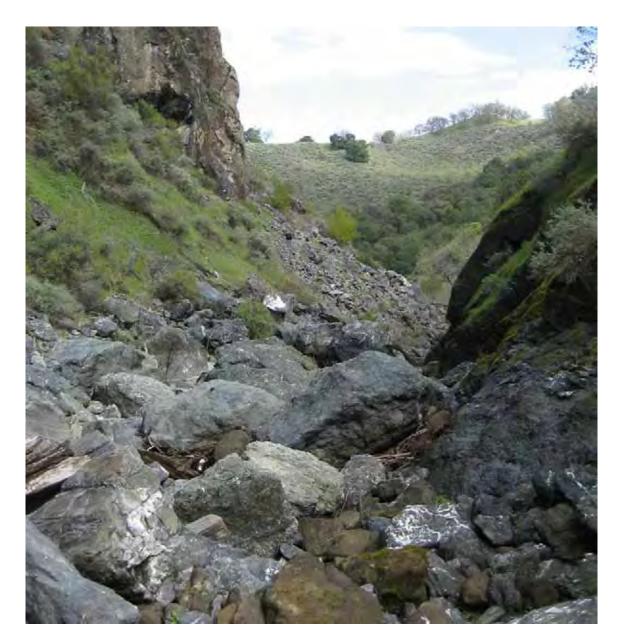
#### Photograph of a Portion of the Calaveras Boulder Debris Field Reach

A portion of the Calaveras boulder debris field reach of Calaveras Creek on March 5, 2009 (looking downstream).

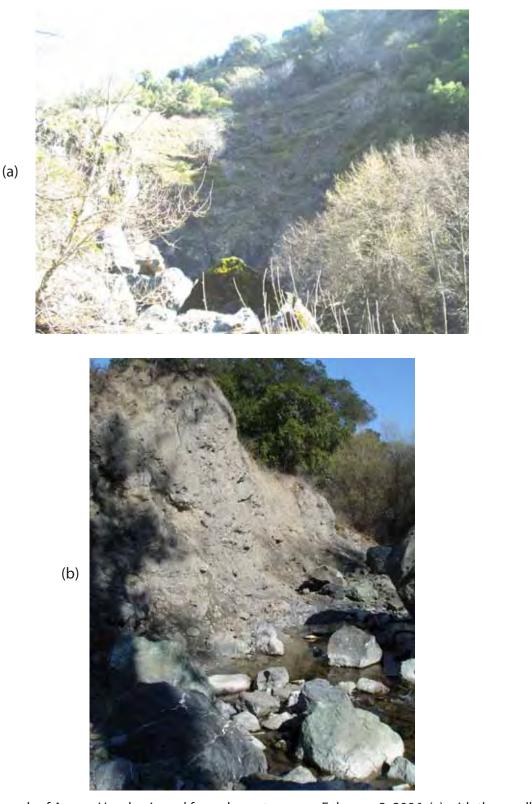
#### Photographs of the Arroyo Hondo Landslide Reach

The landslide reach of Arroyo Hondo viewed from downstream on February 3, 2006, (a) with the smaller of two converging landslides visible on the south canyon wall, and (b) the unstable toe of the north landslide where it meets Arroyo Hondo.

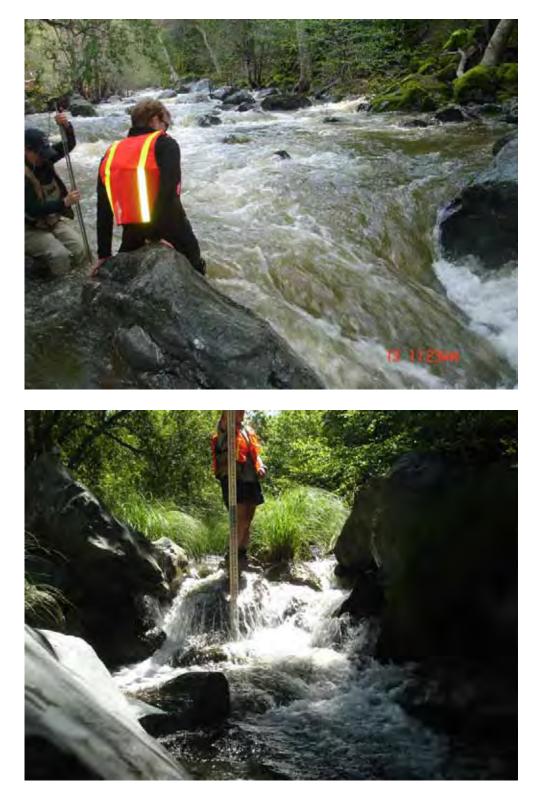
## Photographs of Little Yosemite Feature 2

Example photographs of one (Feature 2) of the readily passable features (Features 1-8) evaluated in the Little Yosemite reach of Alameda Creek (a) on March 13 and (b) June 23, 2006.

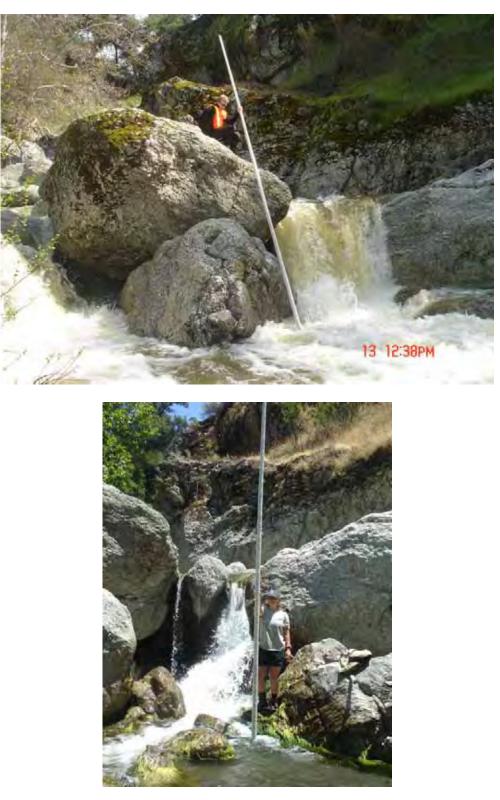
#### Photographs of Little Yosemite Feature 9

Photographs of Feature 9 in the Little Yosemite reach of Alameda Creek, on (a) March 13 and (b) June 23, 2006.

On March 13, 2006, with daily average flow of 98 cfs, flow at Feature 9 was observed to be split by a boulder in the middle of the channel (Figure 4-5 [a]). Passage was visually estimated as impossible at that time. Potential passage routes through spaces between submerged boulders could have been obscured, however, and quantitative measurements of those features could not be obtained due to high flows. Therefore, the passability of this feature was further evaluated during the low-flow field assessment on June 23 before a conclusion regarding its passability could be reached.

At both flows assessed in this memorandum, Feature 9 was determined to be an impassable elevation barrier to steelhead in good condition (and a horizontal distance barrier to steelhead in bright condition). This result is explained below.

In summary, Feature 9 is determined to be impassable by bright steelhead during a flow of 2.5 cfs due to both its vertical height and horizontal range (Figure 4-6). Feature 9 was also determined to be impassable to steelhead in good condition (the condition expected of steelhead potentially immigrating to this feature in the future). The estimated maximum leap height of an adult steelhead in good condition (Cfc = 0.75) in Alameda Creek is 6.1 feet. The distance of the takeoff point from the falls (12.0 feet) reduces the vertical component of the fish's leap due to the reduced angle (63.1°) that the fish must leave the water. This angle reduces the height of the leap from its optimal 6.1 feet to 4.8 feet, and limits the horizontal distance of the leap to 8.8 feet (Figure 4-6). It is assumed that these distances would not be sufficient to negotiate passage by steelhead in good condition at this feature with flows observed during either the March 13 or June 23 field assessment.

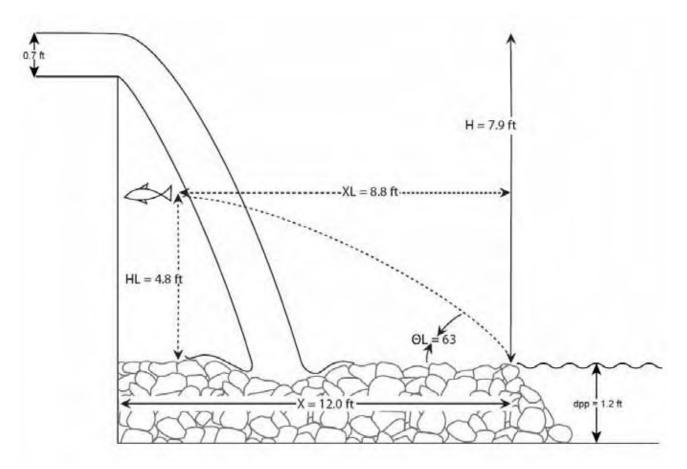
### Figure 4-6 Cross Section of Little Yosemite Feature 9

Table 4-2Parameters Recorded at Feature 9 During a Creek Flow of 2.5 cfs			
Parameter	Data Notation	Measured Value (feet)	
Vertical Height	Н	7.9	
Horizontal Width	X	12	
Depth of Staging Pool	dpp	1.2	
Depth of Landing Site	d <sub>c</sub>	0.7

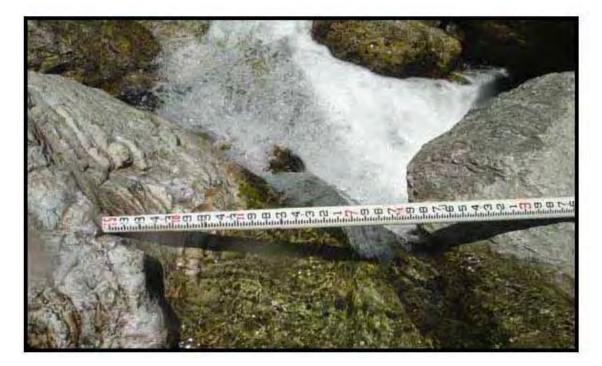
Figure 4-8
 Landing Point of Little Yosemite Passage Feature 9

Finally, it is noted that the landing at the top of the falls (Figure 4-8) is a chute (with a water depth of approximately 8 inches during the lower-flow field assessment) that would require the fish to achieve an adequate burst speed to reach a velocity refuge located approximately 3 feet upstream of the landing point. Figure 4-8 is a photograph taken from the top of the feature looking nearly straight down to show the narrow landing conditions, approximately one-half foot wide, at the top of the falls. It is uncertain if an adult steelhead (even in "bright" condition, Cfc = 1.00) would be able to achieve the level of precision required to navigate through this chute while descending through the air. The velocity of the chute and the distance to a velocity refuge upstream were determined not to be a limiting factor in the passability of this feature. It is unknown whether this feature poses a barrier to upstream migration at flows higher than 98 cfs (Section 5.1).

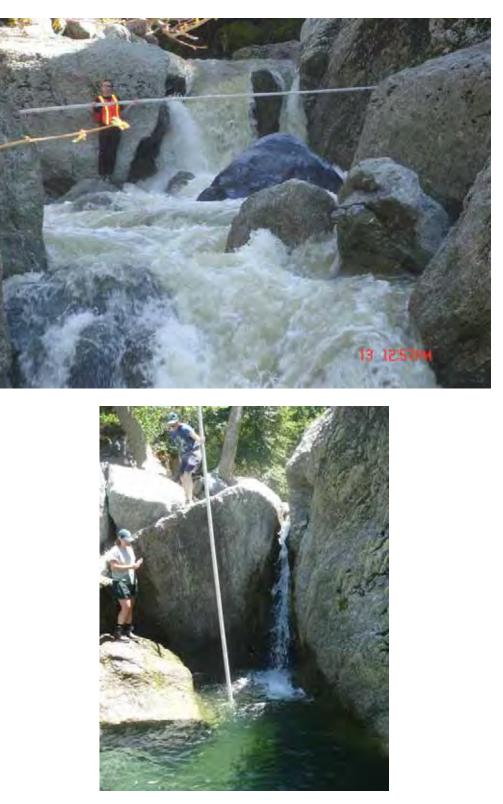
Photographs of Little Yosemite Feature 10

Observations during the June 2006 assessment determined that the only opportunity available for fish to negotiate Feature 10 was to leap the existing falls. Measurements recorded at Feature 10 are shown in Table 4-3. The waterfall has a vertical height (H) of 9.5 feet during a creek flow of 2.5 cfs. The measured horizontal distance (X) from the takeoff point at the standing wave in the plunge pool to the landing is 4 feet (Figure 4-10).

Photographs of Feature 10 in the Little Yosemite reach of Alameda Creek, on (a) March 13 and (b) June 23, 2006.

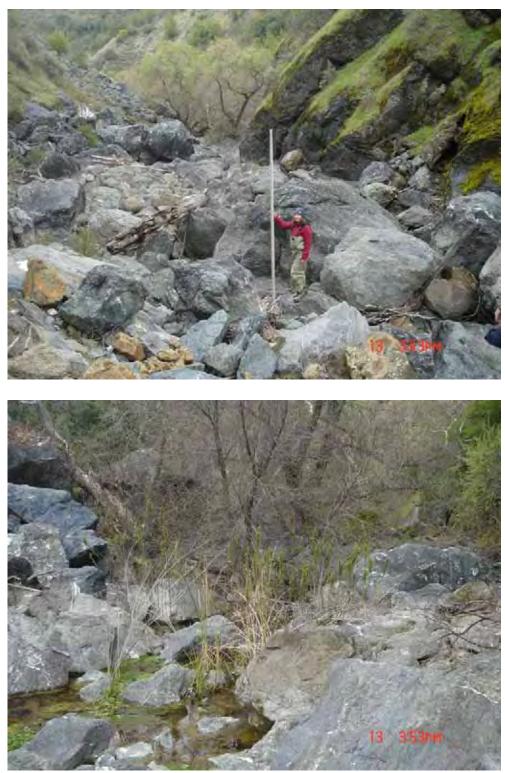
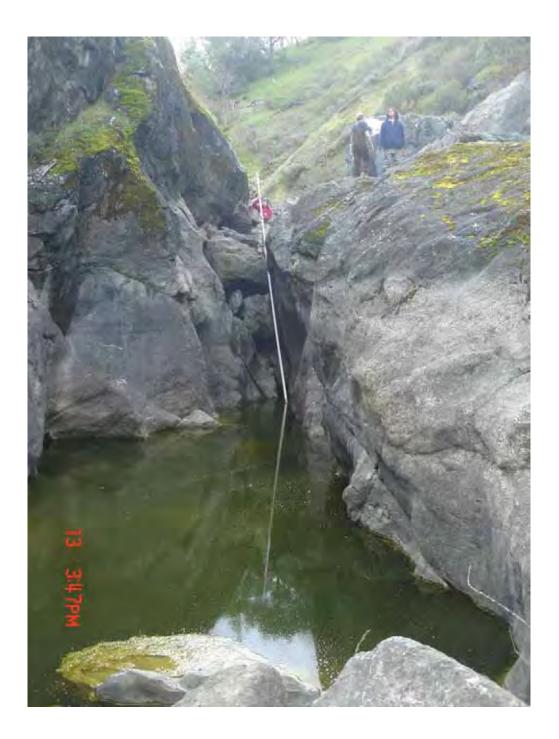
### Waterfall in the **Calaveras Boulder Debris Field Reach**

A waterfall (37.4991°N, 121.8173°W), located approximately 200 feet downstream of the proposed limit of work for Calaveras Dam Replacement Project site, forms an elevation barrier to adult steelhead immigration in Calaveras Creek (Figure 4-13). The apex of the falls is 12 feet from the surface water in the pool below. This feature is currently impassable given that the maximum vertical leap of an Alameda Creek steelhead in good condition would be 6.1 feet (or 10.9 feet for a steelhead in bright condition) under optimal conditions. Although this 12-foot distance could change as the creek rises, and the distance could lessen, the feature was visually estimated to be a barrier during the higher-flow field assessment, when daily average flow was 98 cfs. The rate of flow with potential to lessen the 12-foot height of this barrier is not known at this time.

Similarly, adult steelhead passage through the boulder debris field on Calaveras Creek, below Calaveras Dam, could potentially be facilitated through physical modification. While passage conditions could potentially be affected by massive releases from Calaveras Reservoir, it is uncertain how effective releases would be for facilitating passage. No active slides were observed in this reach, but modifications to facilitate passage would still require investigations of hydrology and geology.

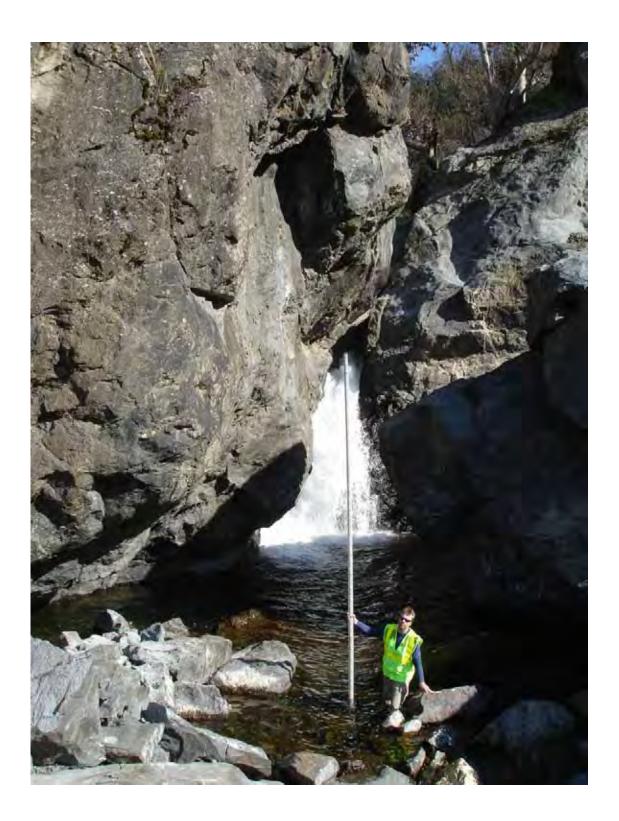
### Waterfall on Arroyo Hondo

The water spills from upstream through a gap in the boulders at the apex of the barrier. The horizontal distance from the leap takeoff point immediately downstream of the standing wave to the landing location at the top of the falls is approximately 3 feet. Although the takeoff pool conditions are good with adequate run-up length and water depth, the falls flow comes from underneath a large accumulation of boulder debris lodged at the top of the falls. This rock overhang above the landing at the top of the falls creates a similar landing access problem as would occur with fish passage at a pipe culvert, where the success of a fish's leap would be limited by the lack of overhead clearance and shallow water depth at the landing site. Additionally, the landing at the top of the falls occurs at the bottom of the enclosed boulder debris chute, which creates an approximately 5-foot-long tunnel through the rock. A fish attempting to negotiate this feature would conceptually be leaping 15 feet up into a tunnel, against the hydraulic head created by water upstream. The water velocities in the tunnel could not be measured due to the enclosed nature of the feature, but if the vertical barrier height did not make the feature impassable, then the landing conditions and the velocity and turbulence of the water from the landing to a velocity refuge would likely make this feature impassable under all anticipated flow conditions.

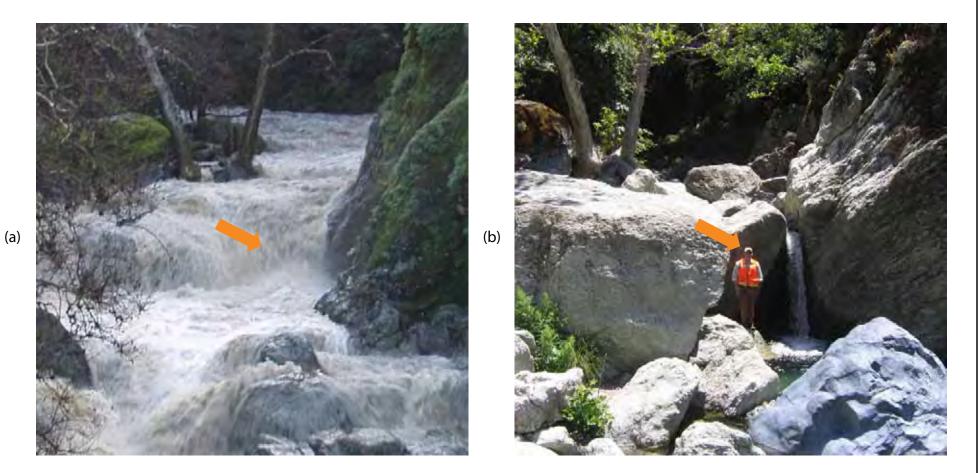
#### Little Yosemite Feature 10 at Low and High Flow

Feature 10 in the Little Yosemite reach of Alameda Creek, (a) on March 4, 2009 with flow of approximately 505 cfs and (b) on May 27, 2009 with flow of less than 1 cfs. The arrow identifies the same location in both photographs.

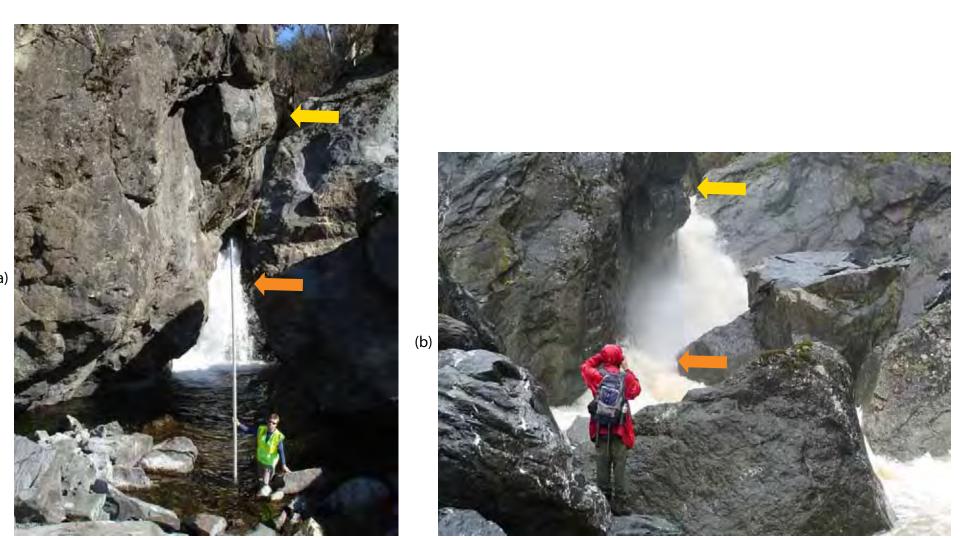
#### Waterfall on Arroyo Hondo at Low and High Flow

Fifteen-foot-high waterfall in the landslide reach of Arroyo Hondo, (a) on February 23, 2006 with flow of approximately 17 cfs, and (b) on March 3, 2009, with flow of approximately 590 cfs. The arrows identify the same locations in both photographs.

Because Arroyo Hondo is an unimpaired tributary, there is no way to influence flows for fish passage. Adult steelhead passage at the waterfall could potentially be facilitated either through direct physical modification or construction of a fish ladder. However, any attempt to facilitate fish passage at this barrier would require extensive geotechnical review due to the instability of the channel slopes (URS, 2009). The landslide on the north canyon wall includes clear evidence of ongoing slide activity and instability, including the toe of the slide immediately adjacent to the channel (Figure 3-6). Given the size of this landslide, as well as the presence of another landslide on the opposite steep canyon wall, channel modifications to facilitate fish passage at Arroyo Hondo would be challenging. Excavation near the north or south channel slopes has potential to destabilize the slides and accelerate their movement, and could require major engineered slope stabilization solutions. Additional investigation and analysis would be required to determine whether such modifications are feasible, or to what extent the slopes would need to be stabilized.
