**Evaluation of the Potential Historical and  
Current Occurrence of  
Steelhead within the Livermore-Amador Valley**

**Prepared for**

Zone 7 Water Agency  
5997 Parkside Dr.  
Pleasanton, CA 94588

August 2004

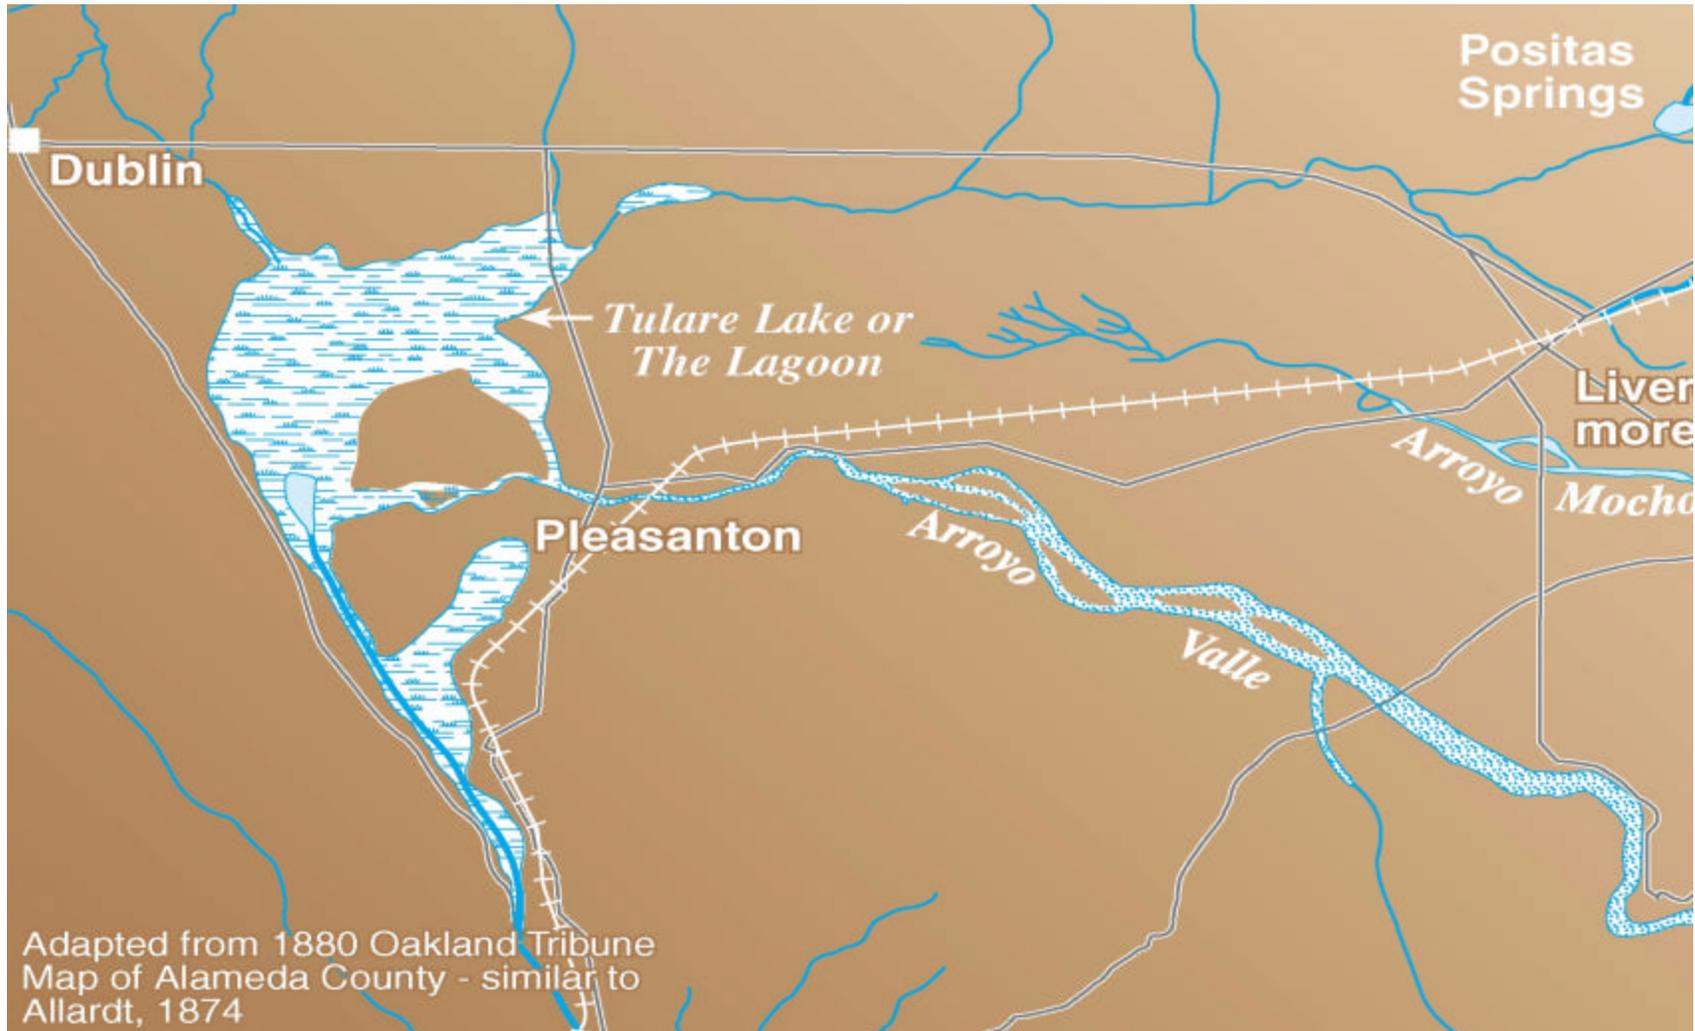
Figure 3. Lower Arroyo Mocho and Arroyo Valle in 1880.

The lower reaches, where the streams cross the valley floor, were the primary subjects of this analysis (Figure 3). Whether fish could swim upstream from the historic lagoon through the lower reaches will determine whether they could have arrived at the suitable spawning and rearing habitat in the upper reaches. In these lower reaches stream flow sinks into the valley alluvium, the stream channels subdivide and widen, and riparian vegetation is relatively sparse.

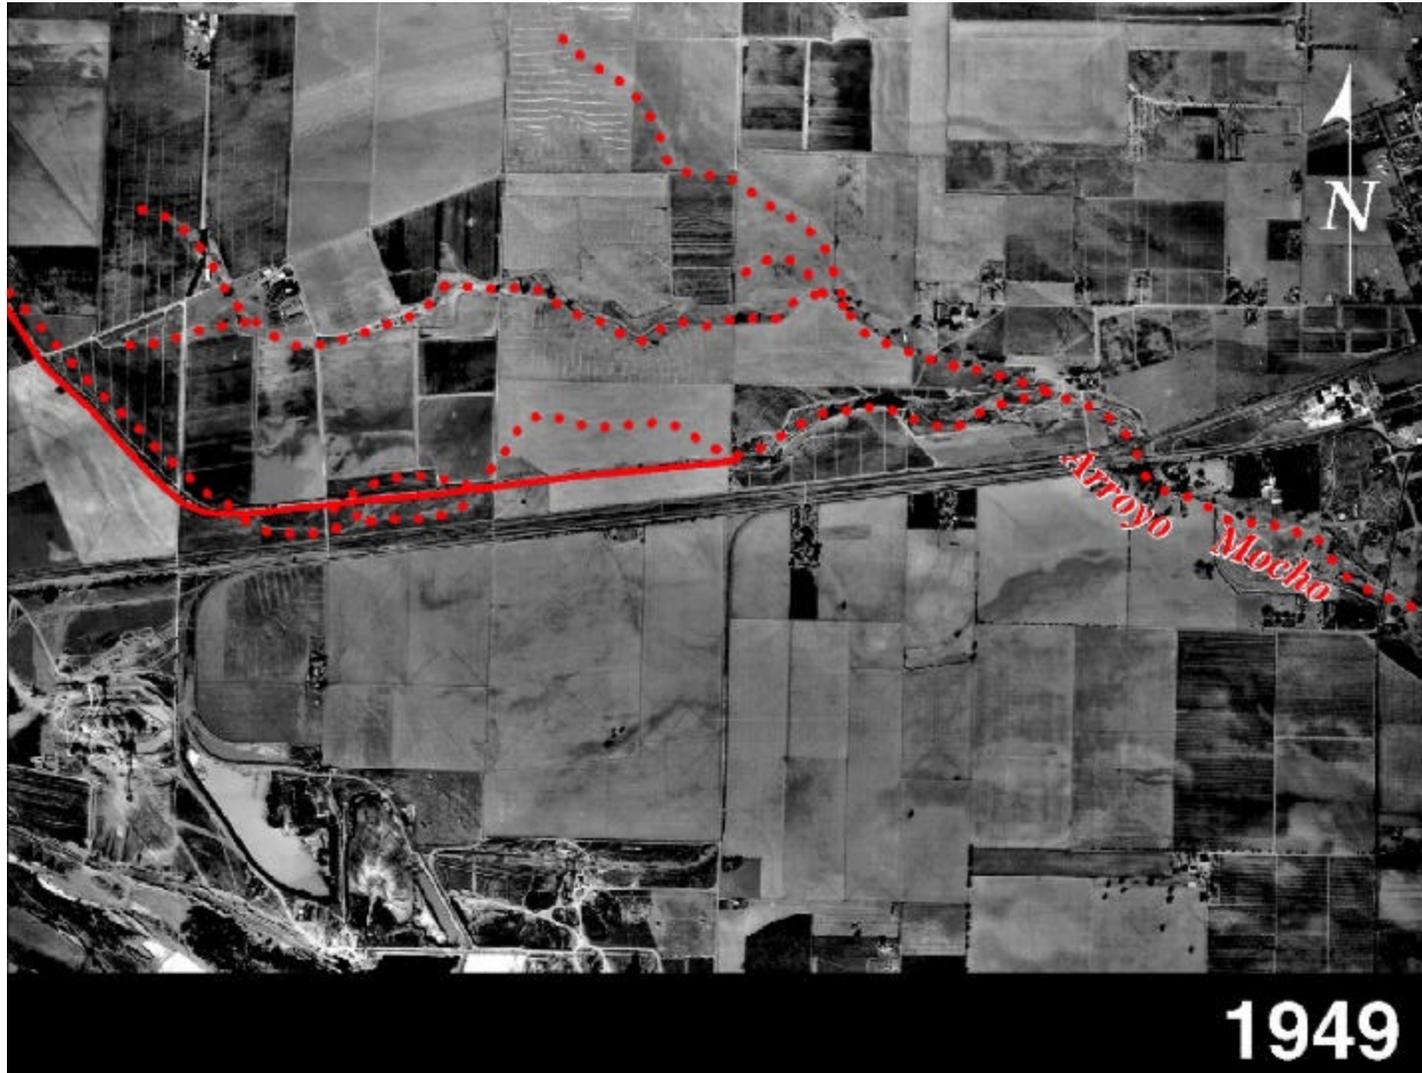
Figure 5a. Aerial photograph and channel overlay (1949) for a portion of lower Arroyo Mocho.

Aerial photography from 1939 and 1949 (Figure 5) provides us an opportunity to document the location of old stream channels before they became obliterated by urban development in the later part of the 20th century. In many cases, the presence of the channels on aerial photography serves as confirmation of channels shown on the historical maps. Channels visible on the photographs were not necessarily active in 1939-49 as the streams had long since been put in ditches, however, the old channels are still visible over much of the landscape. We traced these channels on overlays and compiled them on a master map along with the marsh and lagoon outlines from Allardt (1874) and Williams (1912, after Whitney, 1867), respectively (Figure 6).

The aerial photographs show that both Arroyo Valle and Arroyo Mocho, as well as other streams, subdivided into progressively smaller and more numerous channels as they made their way across the valley floor (Figure 5). Multiple channels can be seen on the photographs, some channels appearing old, discontinuous, and faded, others fresh and clear, suggesting multiple generations of flow over time. Channels are deepest where they exit the hills and become shallower as they progress westward.

It is interesting to note that the small distributary channels are not consistently marked by a line of riparian vegetation (Figure 5). Presumably moisture in these channels is so infrequent and the groundwater table is so low that conditions necessary to support riparian vegetation do not exist. Without the bank stabilizing effect of vegetation, the shifting of channels during large flood events will happen more readily than in a stable vegetated channel.

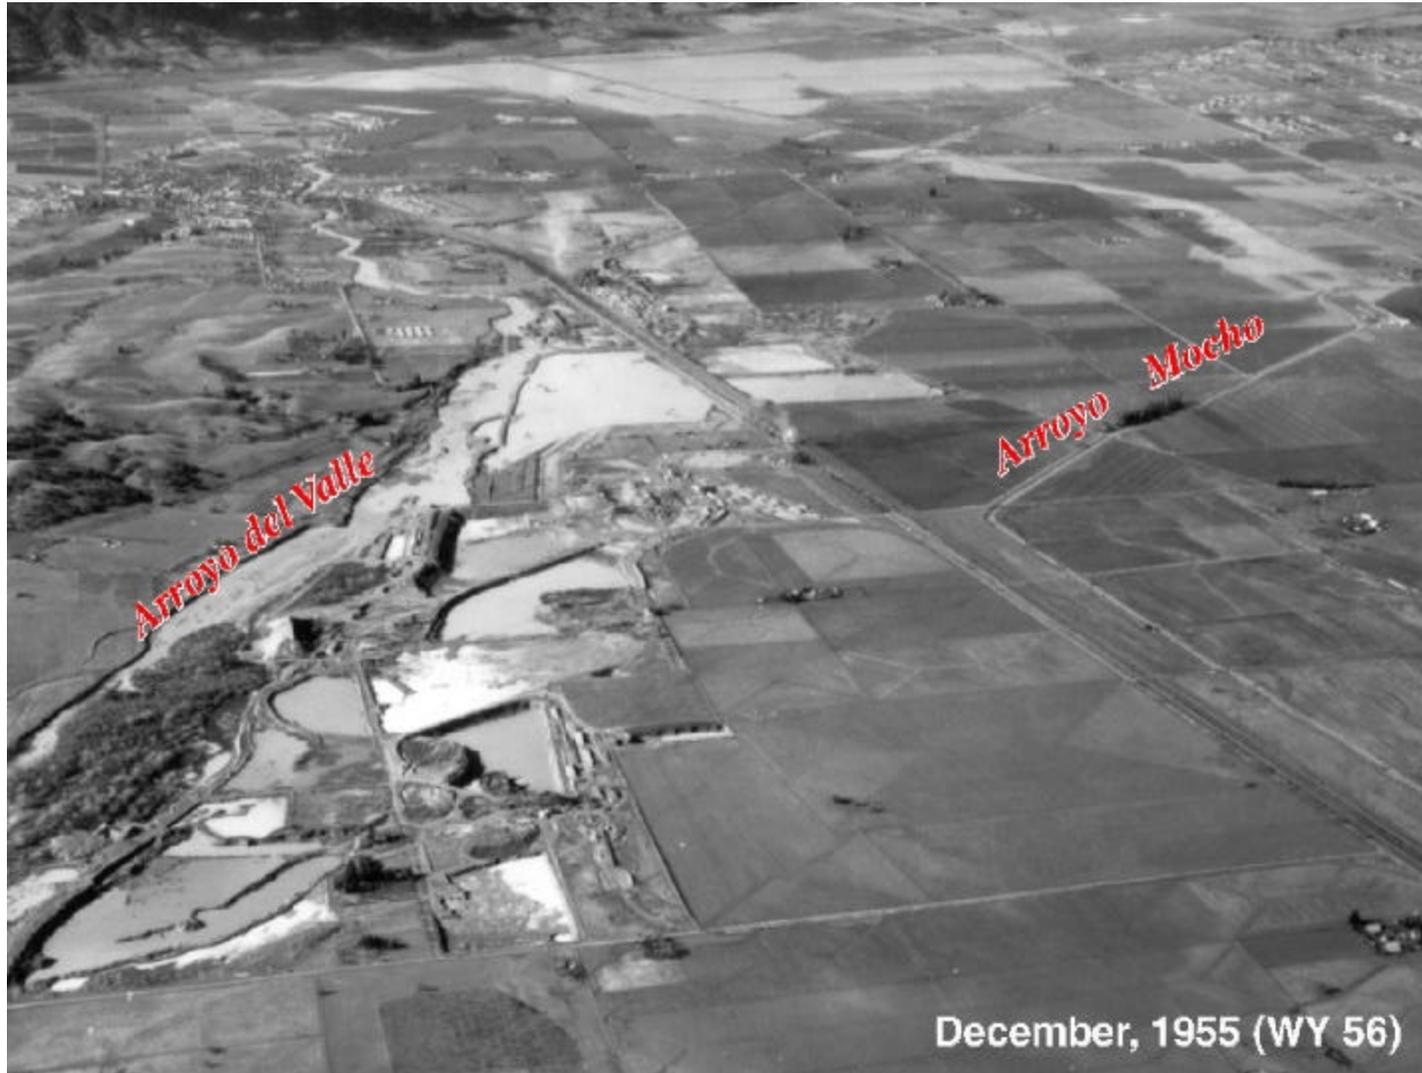
Figure 7. Aerial photograph of lower Arroyo Mocho and Arroyo Valle during high flows in December 1955.

The flood of December 1955 (water year 1956) is the largest flood of record. Its recurrence interval is about 100 years, and that of the 1958 flood about 55 years (Sowers 2003). Photographs and maps of the extent of flooding in both the 1958 and 1955 events show that flow in both Arroyo Mocho and Arroyo Valle did reach the lagoon (Alameda County, 1958) (Figure 7). Furthermore, the lagoon itself, long ago ditched and drained, received so much water from the tributaries that water again stood there in significant depths (Figure7). Under 1950's conditions, it seems safe to assume that passage for fish would have been possible in either stream in the 1956 or 1958 floods.

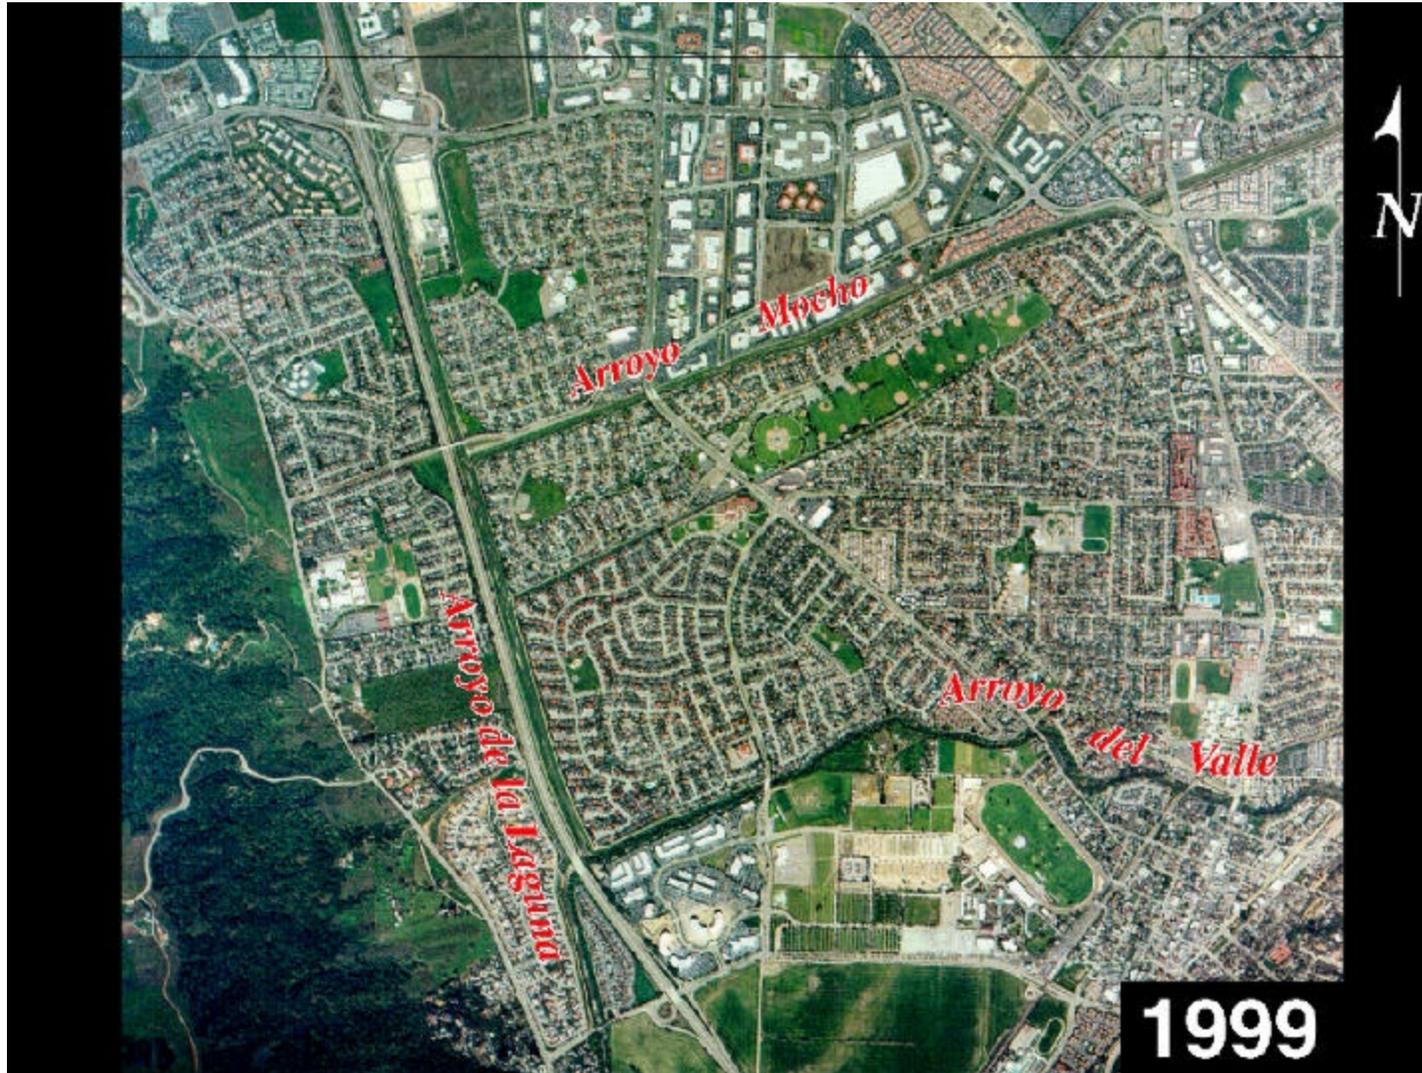
Figure 8. Lower Arroyo Mocho and Arroyo Valle channelized reaches (1999).
