# **Stonybrook Creek Fish Passage Assessment**

**Alameda County  
Public Works Agency**

**MICHAEL LOVE**

**APRIL 6, 2001**

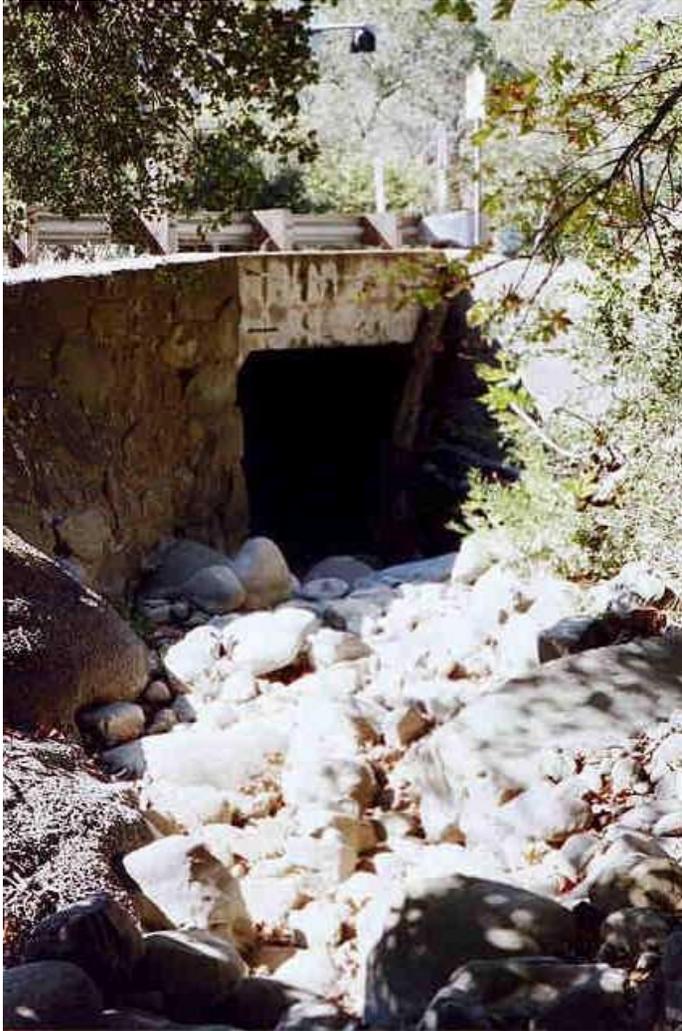
**Culvert Inlet**

The road-crossing on Highway 84 lies at the confluence of Stonybrook Creek with Alameda Creek and is maintained by the California Department of Transportation (CalTrans). Currently, the road-crossing fails to meet passage criteria at all flows. Steelhead are known to have successfully negotiate this culvert under limited flow conditions. Action should be taken to ensure this crossing does not impede migration of steelhead. Additionally, providing access for juvenile and resident steelhead/rainbow trout to Stonybrook Creek should be considered when selecting an alternative due to the cold water refugia the stream provides during summer months.

Replacement of the existing concrete box culvert with a bridge or open-bottom arch spanning the active channel (approximately 20-feet) combined with removing deposited sediment and regrading the upstream channel bed to its natural slope will allow for unimpeded passage of all salmonid lifestages and the efficient transport of stream bed material through the crossing.

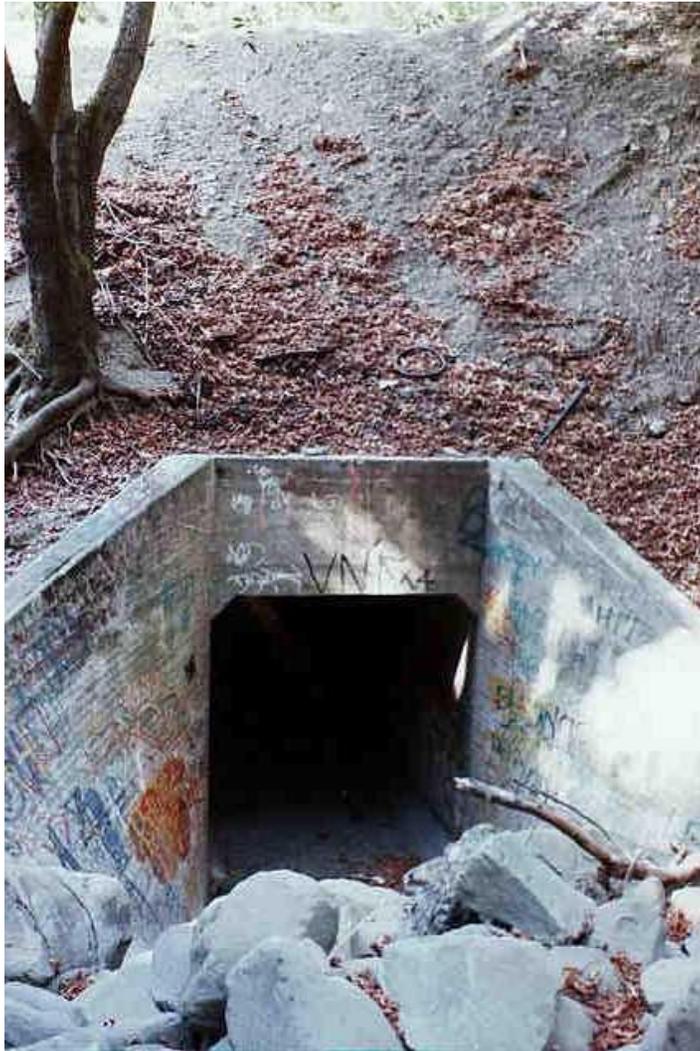
**Culvert Inlet**

The furthest most downstream culvert on Palomares Road is Stobk#2. It is a total barrier based on both the analyses performed as part of this inventory and direct observations made in 1999 (Alexander, 1999). The existing concrete box culvert is undersized, which has caused upstream ponding of water, extreme channel aggradation, and the creation of an 11-foot drop in the channel bed at the inlet. Full replacement of this road-crossing is the only feasible option for providing fish passage.

A pre-fabricated concrete arch placed on concrete footings may be the most suitable replacement structure. Due to the height of the road above the existing crossing, replacement with a bridge would require an extremely long span and likely be cost-prohibited. The new crossing should have a span of at least 20-foot to allow unimpeded transport of bedload, comprised primarily of boulders. To eliminate the 11-foot drop above the existing culvert inlet, the stream should be recontoured at an average channel slope of approximately 8.5%. Although the channel would be relatively steep, using an open bottom arch containing natural boulder substrate should encourage the formation of pools throughout the reach and create suitable fish passage and habitat conditions.

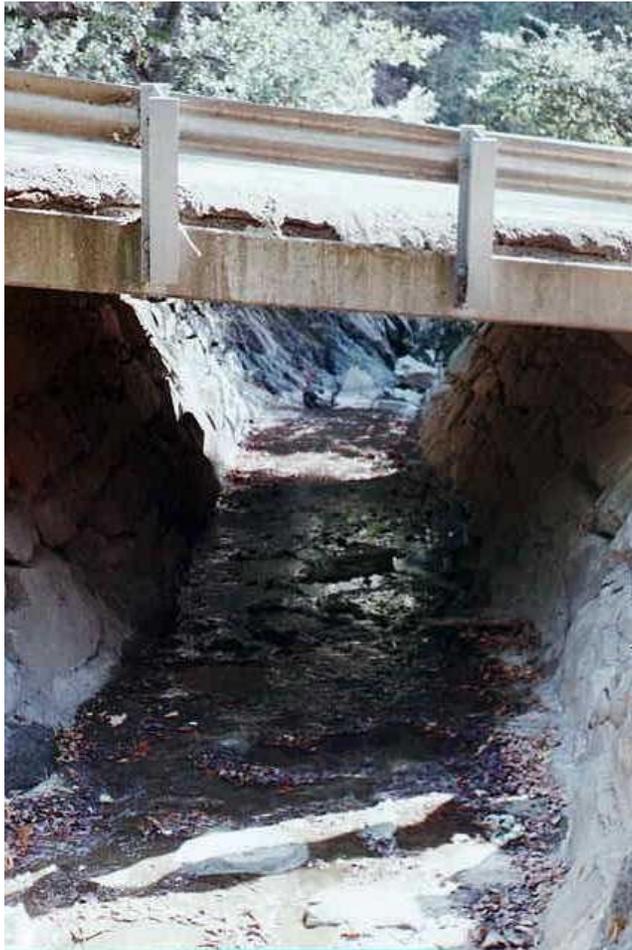
**Inlet of Road-Crossing**

The road-crossing at milepost 8.60 is extremely undersized, causing scour of the downstream channel through excessive outlet water velocities at high flows. As a result the channel has locally degraded approximately 5-feet at the culvert outlet. The most suitable solution for eliminating the fish passage barrier is full replacement of the crossing with a bridge or open bottom arch with a span of approximately 20-feet.

Because Stobk#3 through Stobk#8 are historic structures constructed in the 1930's, replacement may be difficult. For Stobk#3, an interim solution may be installing a fishway at the culvert outlet combined with fish weirs within the crossing to provide for upstream passage of adult steelhead and possibly larger rainbow trout. A steep-pass or denial fish ladder leading from the outlet pool to the apron could be mounted onto the bedrock wall along the left side of the channel. Weirs would need to be installed throughout the crossing to provide adequate water depth and reduced velocities. As part of the retrofit, the existing floor throughout the crossing should be relined with concrete and a headwall installed below the outlet apron.

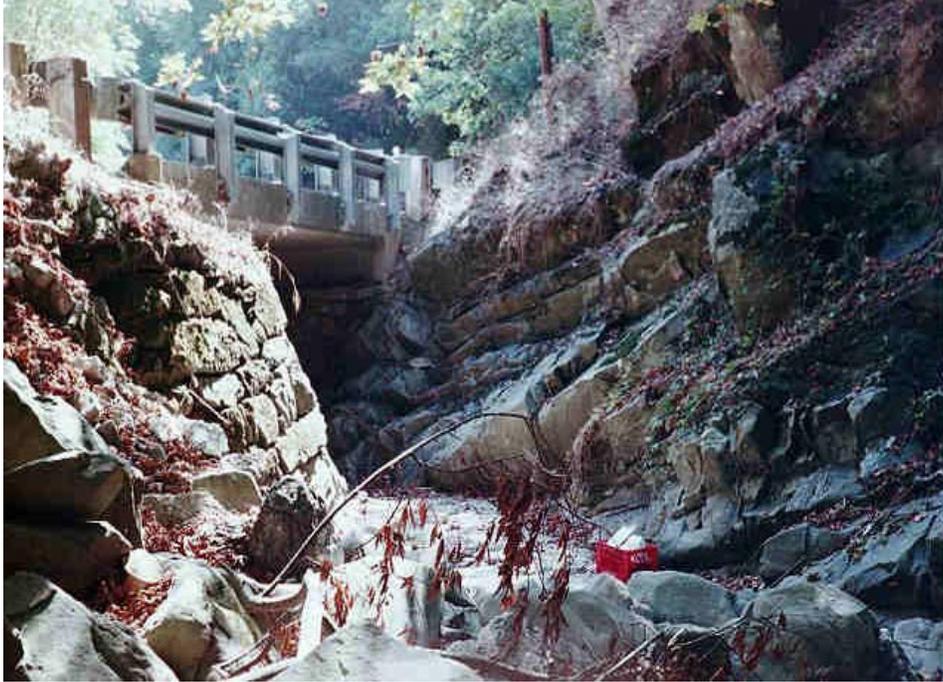
**Road-Crossing Inlet**

Stobk#5	Palomares Road	8.00	Insufficient water depth and excessive water velocities at all migration flows makes this crossing a complete barrier to all fish.
Stobk#6	Palomares Road	7.57	Perched outlet and steep outlet apron makes crossing complete barrier to juvenile and resident salmonids. Additionally adult depth criteria for fish passage is insufficient along apron at all migration flows. Some stronger swimming individual steelhead w
Stobk#7	Palomares Road	6.28	Insufficient water depth and excessive water velocities across the outlet apron creates a complete barrier to all fish. Some stronger adult steelhead may be able to negotiate the crossing at moderate flows.
Stobk#8	Palomares Road	6.18	100% passable for all species and lifestages due to concrete weir at outlet.

between the two crossings, they should be considered for barrier remediation at the same time. The preferred option for providing fish passage at both of these road-crossings is to replace them with bridges or open bottom arches spanning the active channel.
