TECHNICAL MEMORANDUM

ASSESSMENT OF FISH UPSTREAM
MIGRATION AT NATURAL BARRIERS
IN THE UPPER ALAMEDA CREEK
SUB-WATERSHED

Prepared for
San Francisco Public Utilities Commission

January 2010

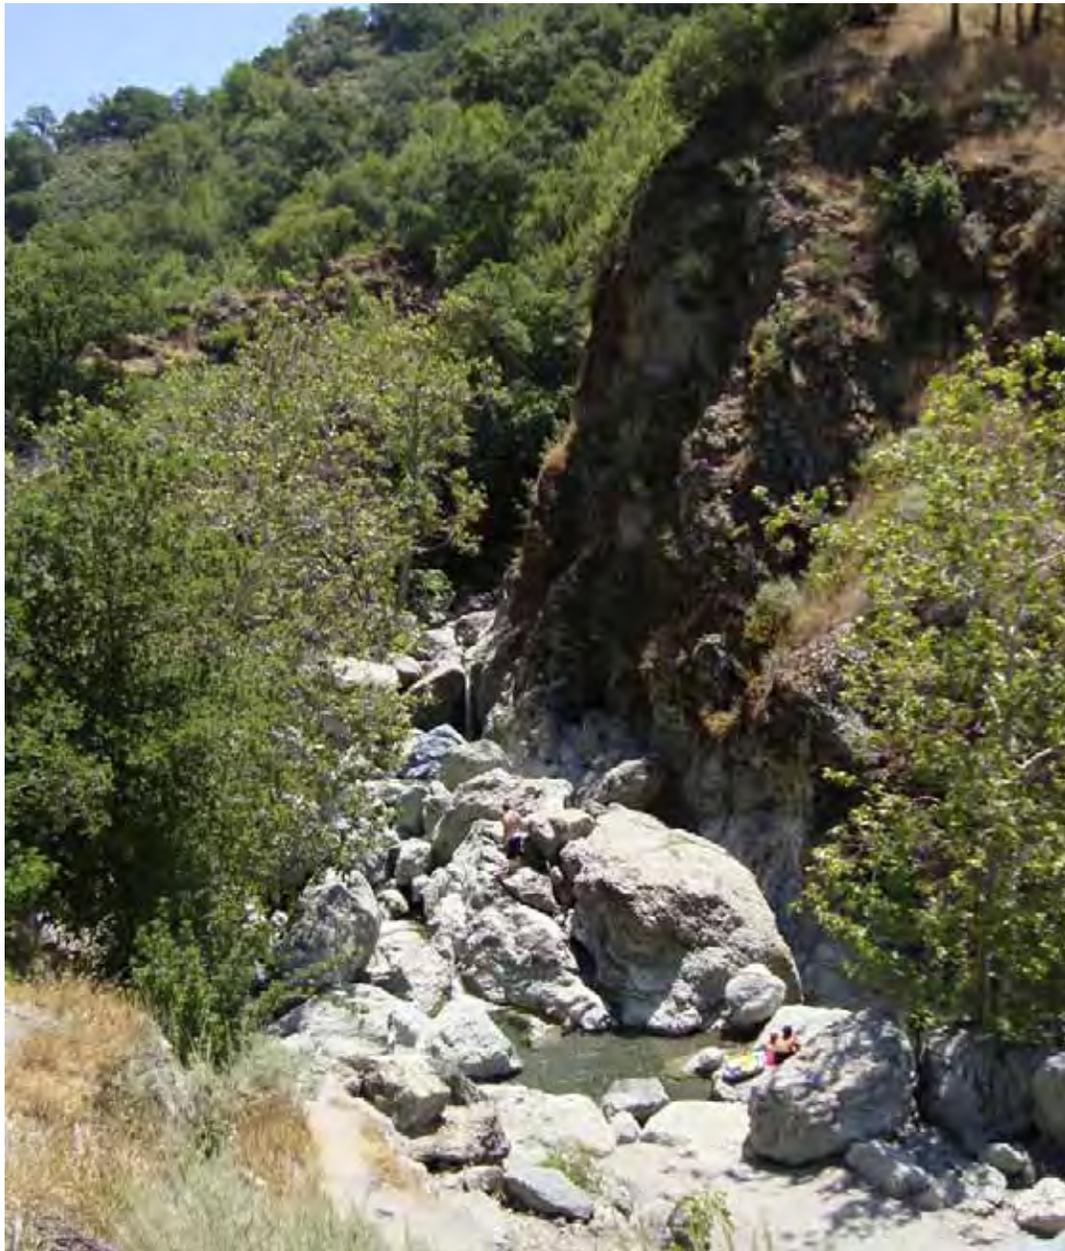
Figure 3-1

A portion of the Little Yosemite reach of Alameda Creek on May 27, 2009
(recreational users of Sunol Regional Wilderness in foreground)

Photograph of a Portion of the Little Yosemite Reach

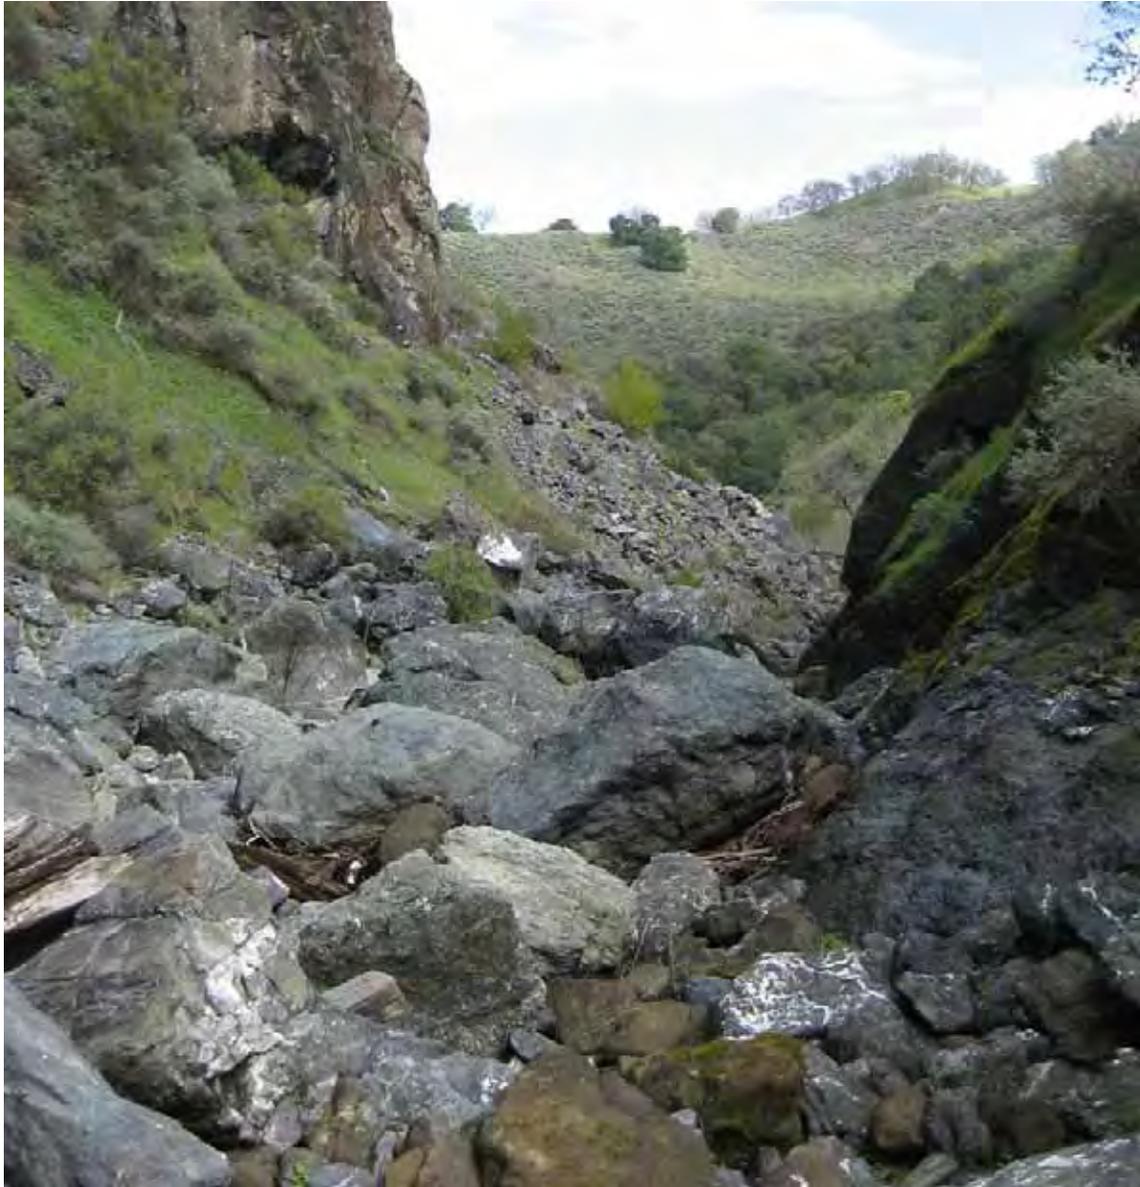
A portion of the Calaveras boulder debris field reach of Calaveras Creek on March 5, 2009 (looking downstream).

**Photograph of a Portion of the
Calaveras Boulder Debris Field Reach**

Similarly, adult steelhead passage through the boulder debris field on Calaveras Creek, below Calaveras Dam, could potentially be facilitated through physical modification. While passage conditions could potentially be affected by massive releases from Calaveras Reservoir, it is uncertain how effective releases would be for facilitating passage. No active slides were observed in this reach, but modifications to facilitate passage would still require investigations of hydrology and geology.

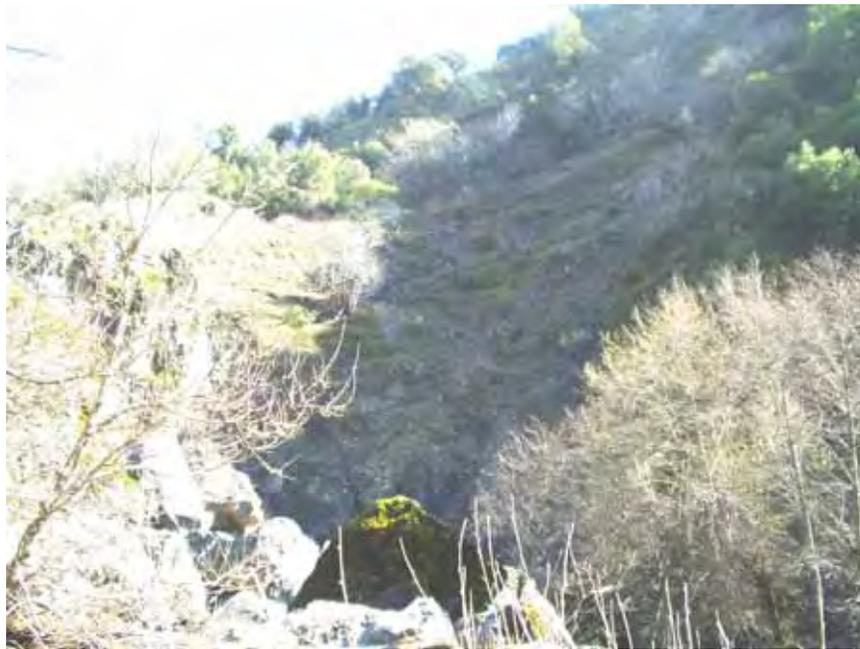
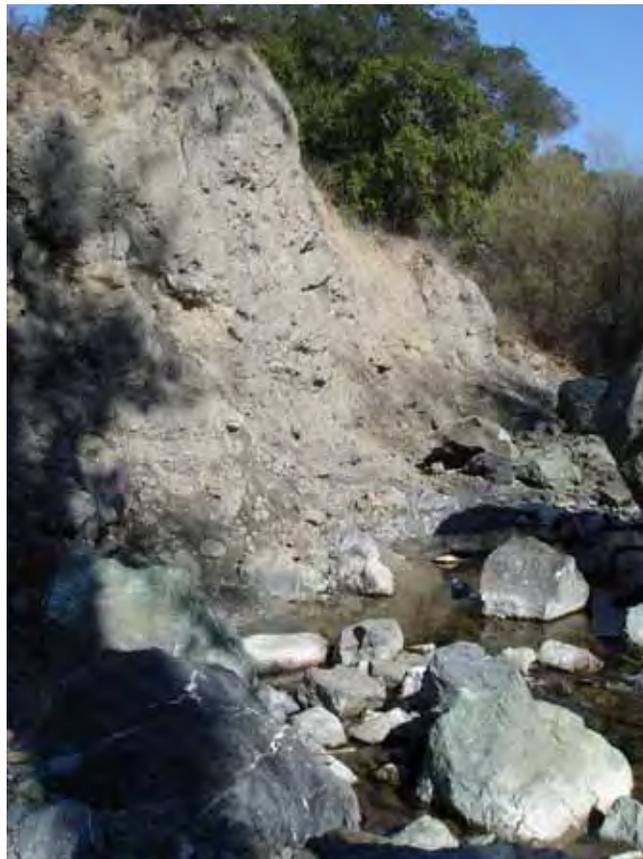
The landslide reach of Arroyo Hondo viewed from downstream on February 3, 2006, (a) with the smaller of two converging landslides visible on the south canyon wall, and (b) the unstable toe of the north landslide where it meets Arroyo Hondo.

**Photographs of the Arroyo Hondo
Landslide Reach**

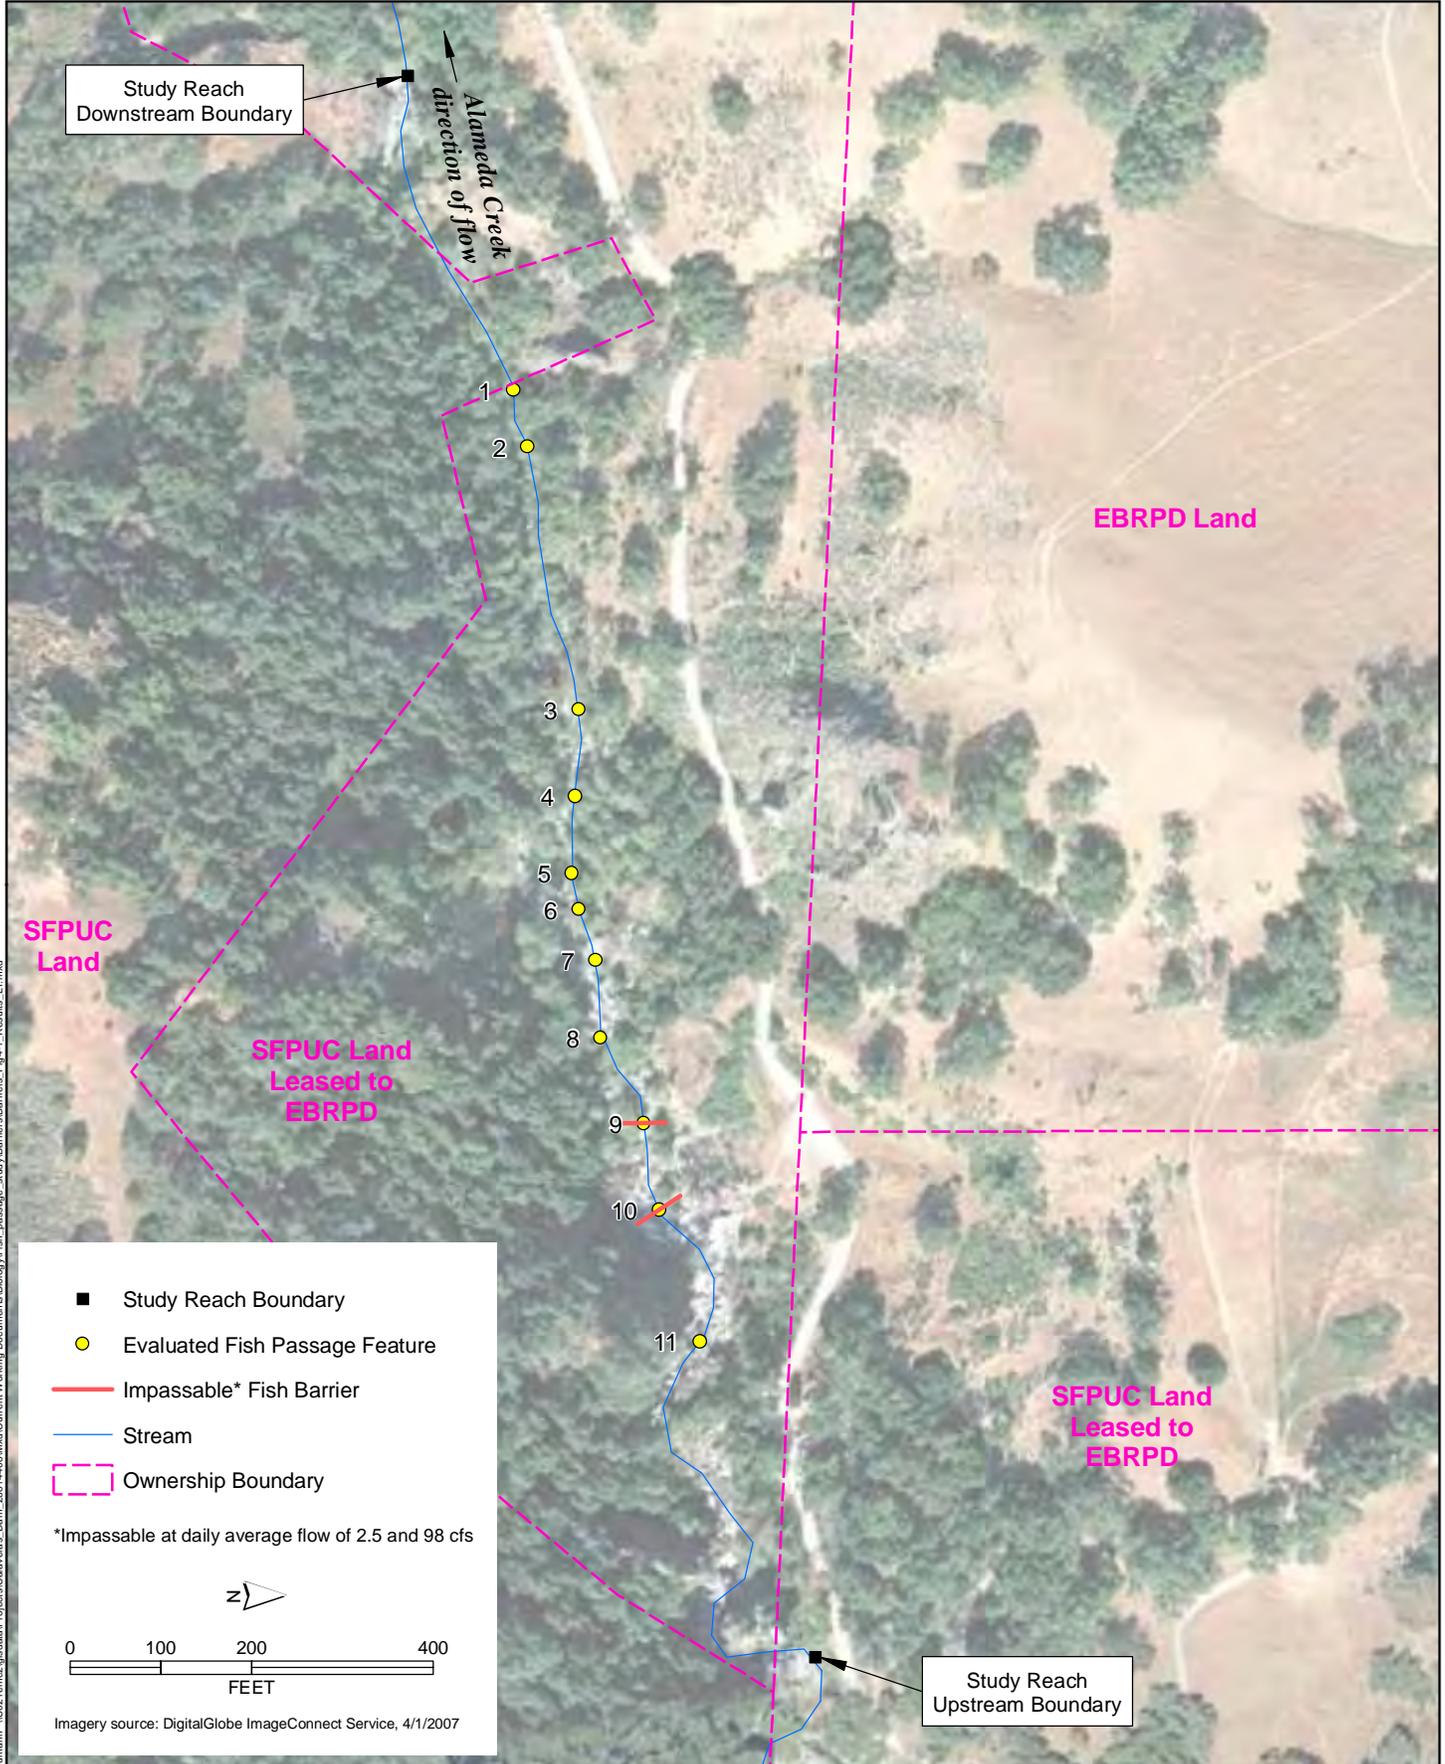
Of the 11 features surveyed, eight features (Features 1 through 8) met the criteria representing passable conditions during both field assessments (Figure 4-4; Table 4-1), while Features 9, 10, and 11 required more detailed analyses to determine passability (Figures 4-5, 4-9, and 4-11). Summary information from the studies of Features 9, 10, and 11 is presented in the following sections.

Barrier Assessment Results for Little Yosemite
 Assessment of Fish Upstream Migration at Natural Barriers
 in the Upper Alameda Creek Sub-Watershed
 Technical Memorandum
 January 2010 Figure 4-1

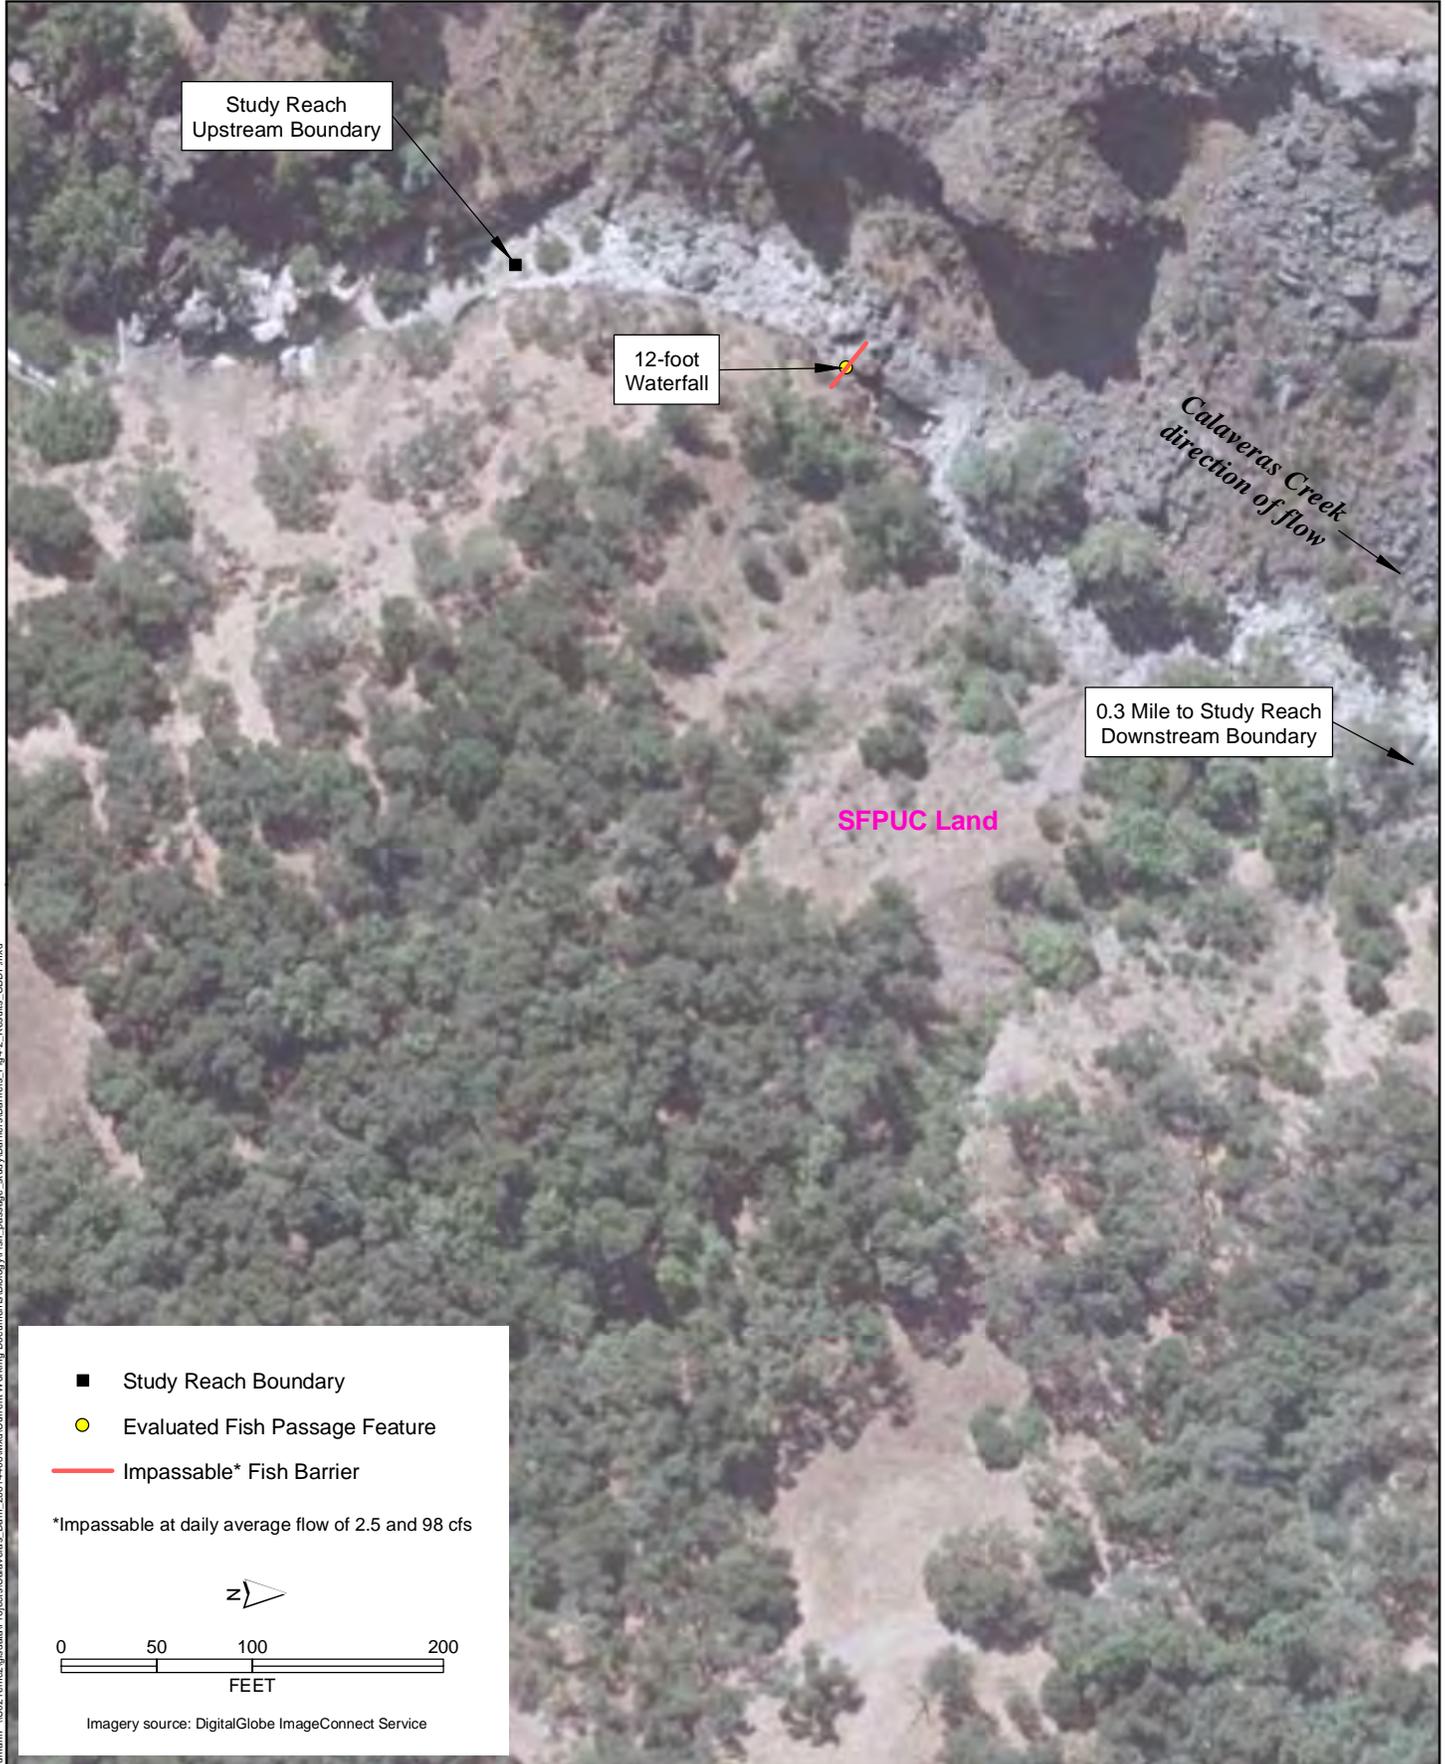
Below Calaveras Dam, the boulder debris field reach of Calaveras Creek was also found to be impassable to immigrating adult steelhead. While a number of small impediments and subsurface flows may affect passage conditions at times of low stream flow, the primary barrier to steelhead migration is a 12-foot vertical waterfall. This feature is impassable because its vertical height exceeds the vertical leaping ability of steelhead, even under optimal conditions. The passability of the 12-foot-high waterfall in Calaveras Creek may be affected by changes in flow, controlled almost entirely by operation of Calaveras Dam, but it is unknown whether increases in stream discharge would improve hydraulic conditions sufficient for passage at this barrier.

Barrier Assessment Results for Calaveras Boulder Debris Field

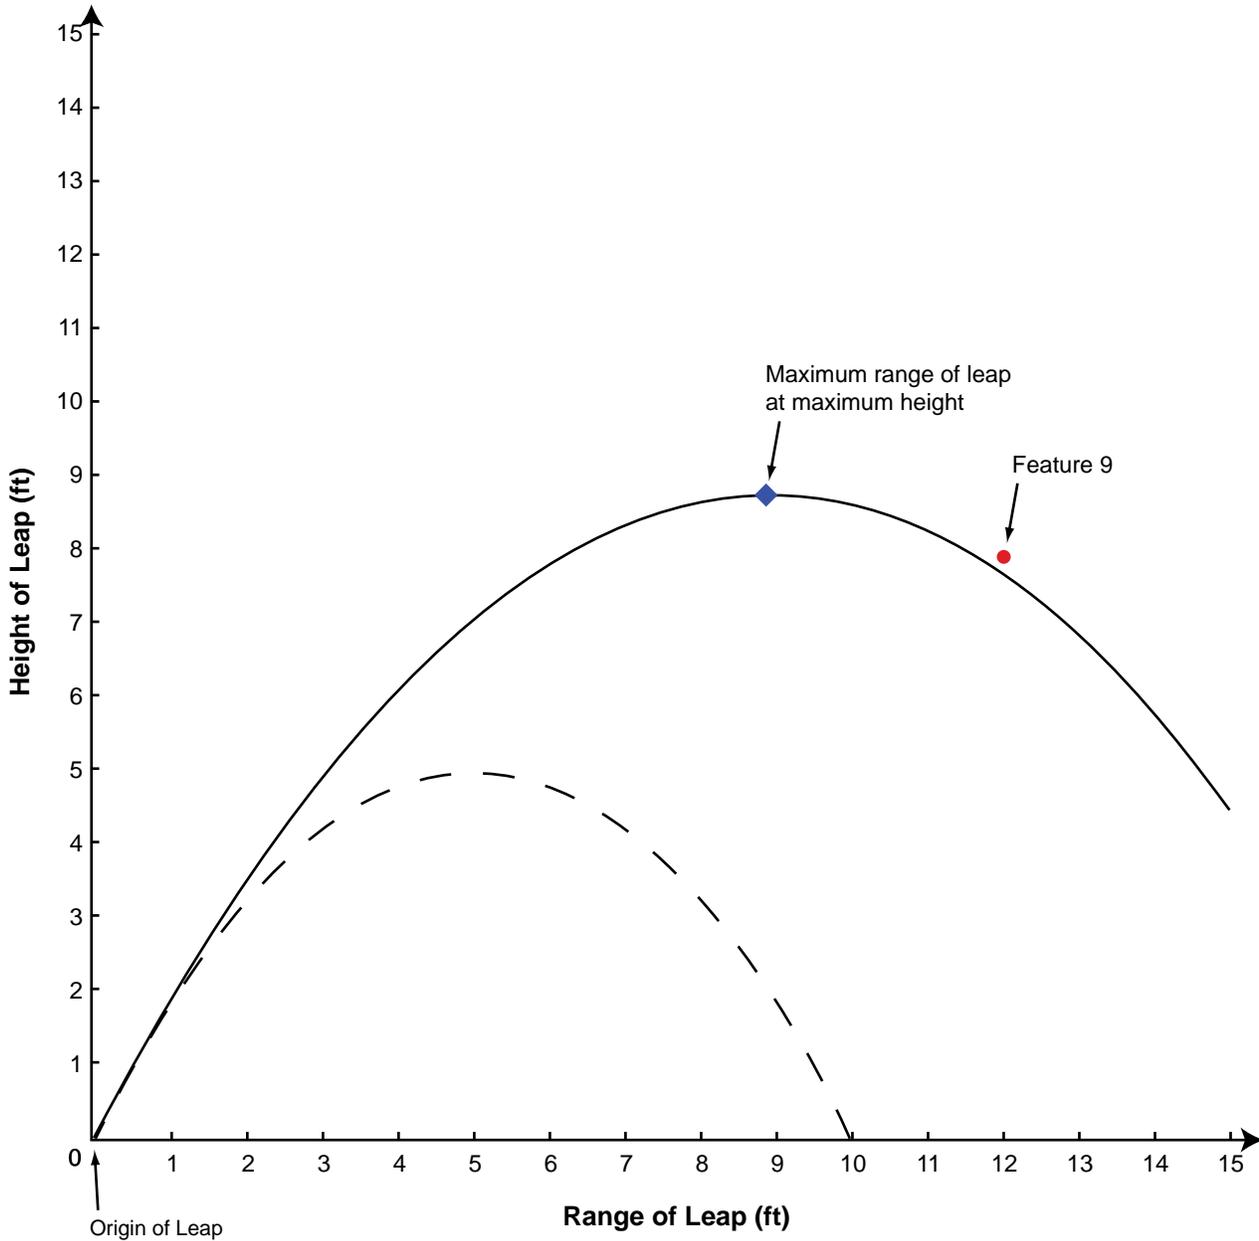
According to the calculated leaping angle of 63.1° , the fish reaches its highest point at a horizontal distance of 8.8 feet, represented by the blue diamond in Figure 4-7. A horizontal distance of 8.8 feet is not sufficient to reach a barrier with a horizontal distance of 12.0 feet, as illustrated. The trajectory of the fish, represented by the solid black line, shows that the fish will not clear the barrier. Thus, an anadromous steelhead trout (burst speed = 26.5 fps) with a coefficient of fish condition of 1.0 could have leaped either the vertical or the horizontal component of the jump but could not have jumped both components simultaneously. With respect to Feature 9, the answer for Step 3 is "no," resulting in the classification of Feature 9 as a horizontal distance barrier for steelhead in bright condition.

In summary, Feature 9 is determined to be impassable by bright steelhead during a flow of 2.5 cfs due to both its vertical height and horizontal range (Figure 4-6). Feature 9 was also determined to be impassable to steelhead in good condition (the condition expected of steelhead potentially immigrating to this feature in the future). The estimated maximum leap height of an adult steelhead in good condition ($Cfc = 0.75$) in Alameda Creek is 6.1 feet. The distance of the takeoff point from the falls (12.0 feet) reduces the vertical component of the fish's leap due to the reduced angle (63.1°) that the fish must leave the water. This angle reduces the height of the leap from its optimal 6.1 feet to 4.8 feet, and limits the horizontal distance of the leap to 8.8 feet (Figure 4-6). It is assumed that these distances would not be sufficient to negotiate passage by steelhead in good condition at this feature with flows observed during either the March 13 or June 23 field assessment.
