# ASSESSMENT OF FISH UPSTREAM MIGRATION AT NATURAL BARRIERS IN THE UPPER ALAMEDA CREEK SUB-WATERSHED

Prepared for San Francisco Public Utilities Commission

January 2010

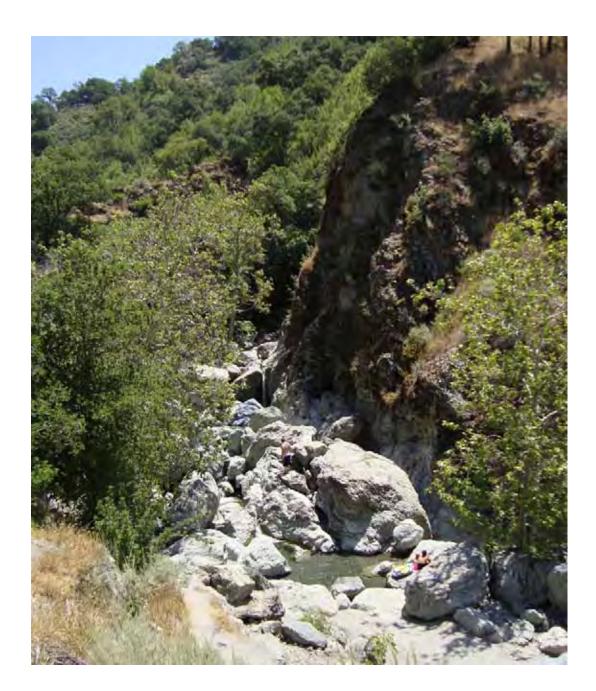
Photograph of a Portion of the Little Yosemite Reach

A portion of the Little Yosemite reach of Alameda Creek on May 27, 2009 (recreational users of Sunol Regional Wilderness in foreground)

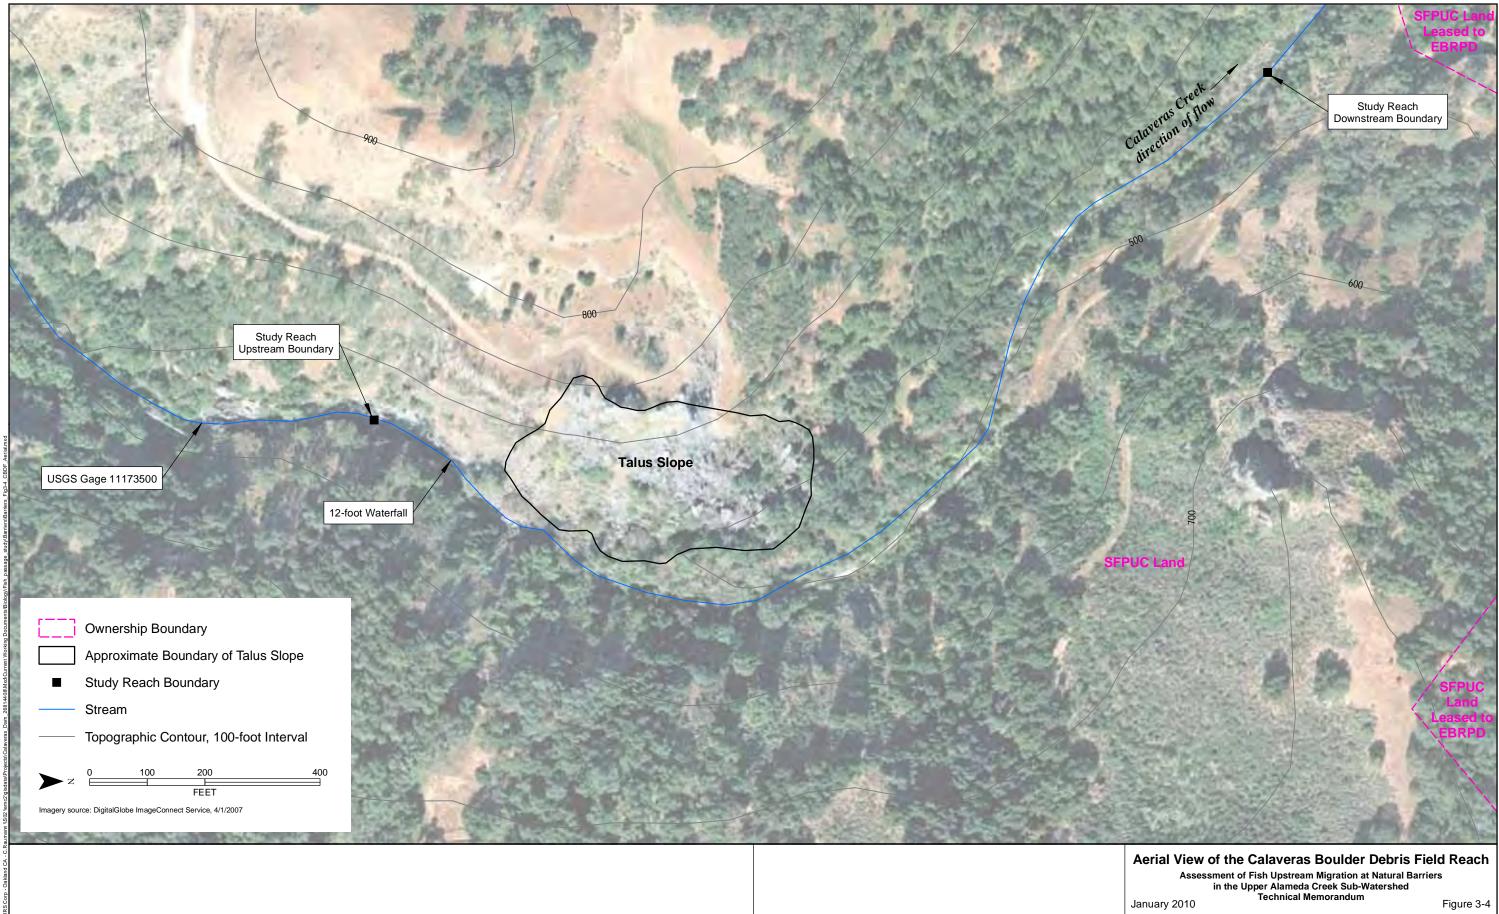
#### Photograph of a Portion of the Calaveras Boulder Debris Field Reach

A portion of the Calaveras boulder debris field reach of Calaveras Creek on March 5, 2009 (looking downstream).

the boulders, indicating that some rocks in the channel were generated in the upslope rock borrow area. The smaller rocks present on the talus slope and in Calaveras Creek below the borrow area are less weathered than the larger boulders present in the reach, which are well eroded by flow. The largest boulders appear to have weathered out of the native rock, are present upstream and downstream of the borrow area, and do not appear to be related to the rock borrow operations.

A 12-foot vertical step is present in the channel about 200 feet below the upstream limit of the study reach. The step has formed where stream flow has eroded a jointed portion of bedrock in the channel bottom and the eroded area has backfilled with boulders that are wedged into the eroded slot (URS, 2009). Several very large boulders or eroded bedrock remnants trap much of the alluvium in the channel there, creating an approximately 12-foot waterfall when surface flows are present (Figure 3-4). Although not evaluated in detail, this waterfall appears to be a natural feature.

Similarly, adult steelhead passage through the boulder debris field on Calaveras Creek, below Calaveras Dam, could potentially be facilitated through physical modification. While passage conditions could potentially be affected by massive releases from Calaveras Reservoir, it is uncertain how effective releases would be for facilitating passage. No active slides were observed in this reach, but modifications to facilitate passage would still require investigations of hydrology and geology.

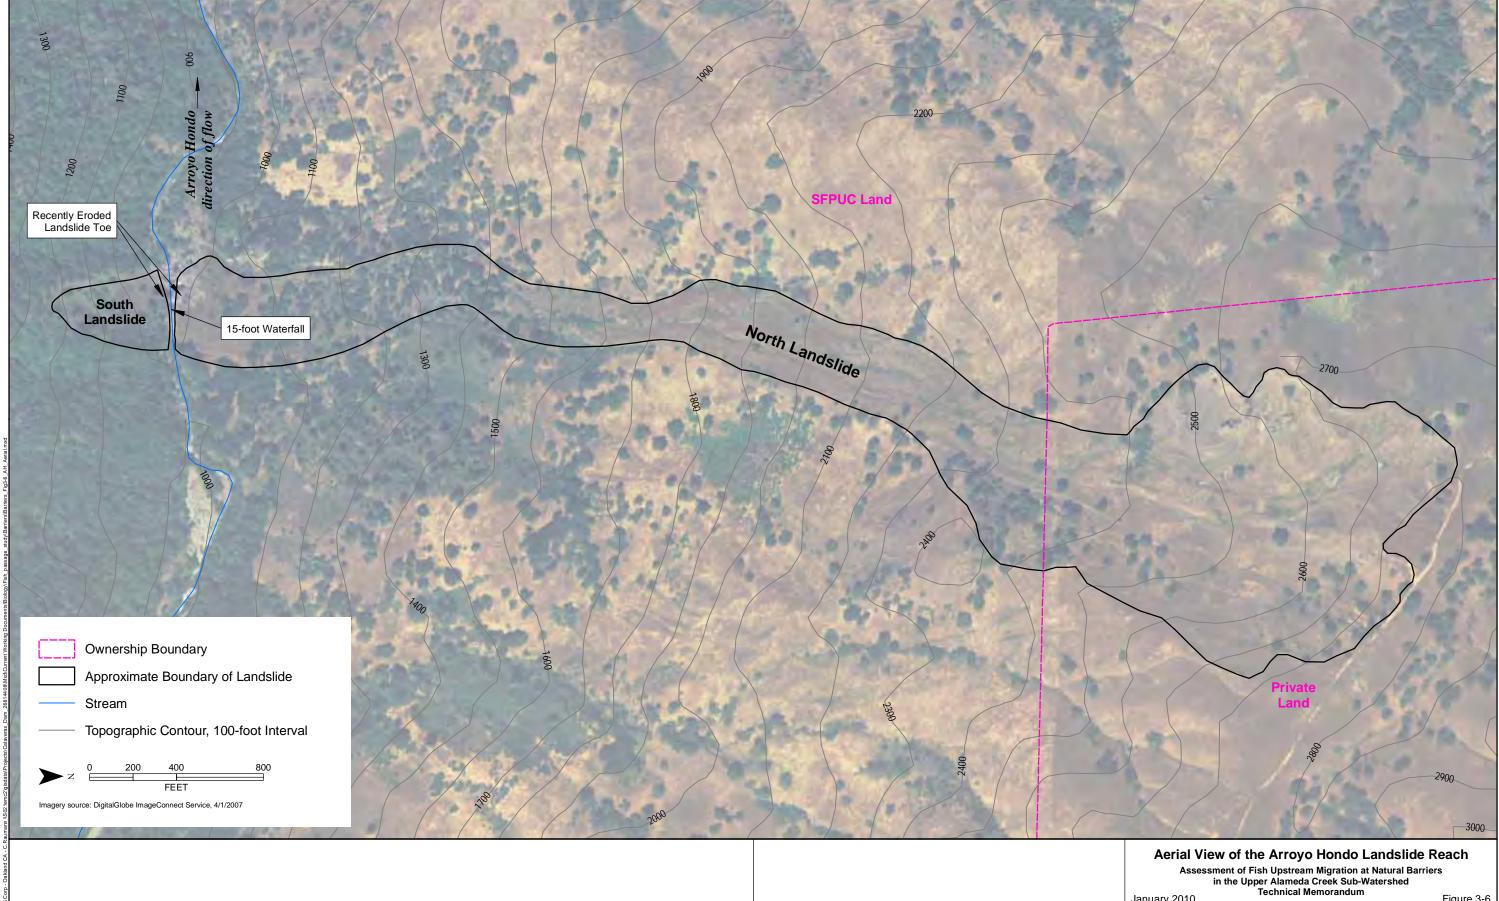
Figure 3-6

The Arroyo Hondo landslide reach is located approximately 1.8 miles upstream from the confluence of Arroyo Hondo and the full pool water surface elevation of Calaveras Reservoir (Figure 2-1). At this location (Figure 3-5 [a]) two landslides converge on Arroyo Hondo (Figure 3-6). Much of the channel is choked with large, 6-foot to greater than 50-foot-diameter boulders, creating potential impediments to fish immigration, including an approximately 15-foot waterfall. The channel gradient in the steepest sections is between 13 and 16 percent.

Of the two landslides, the one that extends approximately 2,000 feet up the north canyon wall from the creek elevation is the larger (Figure 3-6). Many of the boulders that are present in the bottom of the canyon were part of this landslide (Nilsen, 1975b; Dibblee, 1973), which shows signs of recent activity over most of its length and continues to be unstable (URS, 2009). Another much smaller, but still large landslide is present on the south side of the stream; this second landslide extends up the south canyon slope to an elevation of about 1,500 feet. While many of the large boulders resting in the creek channel at this location were likely originally part of these landslide masses, the two largest "boulders" that create an approximately 15-foot-high waterfall may be bedrock outcrops.

The large northern landslide (and possibly the smaller southern landslide as well) appears to have been initiated by stream erosion at the toe of the slope, probably many thousands of years ago (URS, 2009). Farther upslope portions of the slide have sequentially become destabilized as adjacent downslope soil and rock materials have begun to move. The toes of both of these landslides are actively creeping down into the creek channel where the finer soil and weathered rock get washed away during periods of high stream discharge (Figure 3-5 [b]). The rocks and boulders currently in the channel appear to be providing a limited degree of buttressing against the toe of the northern slide.

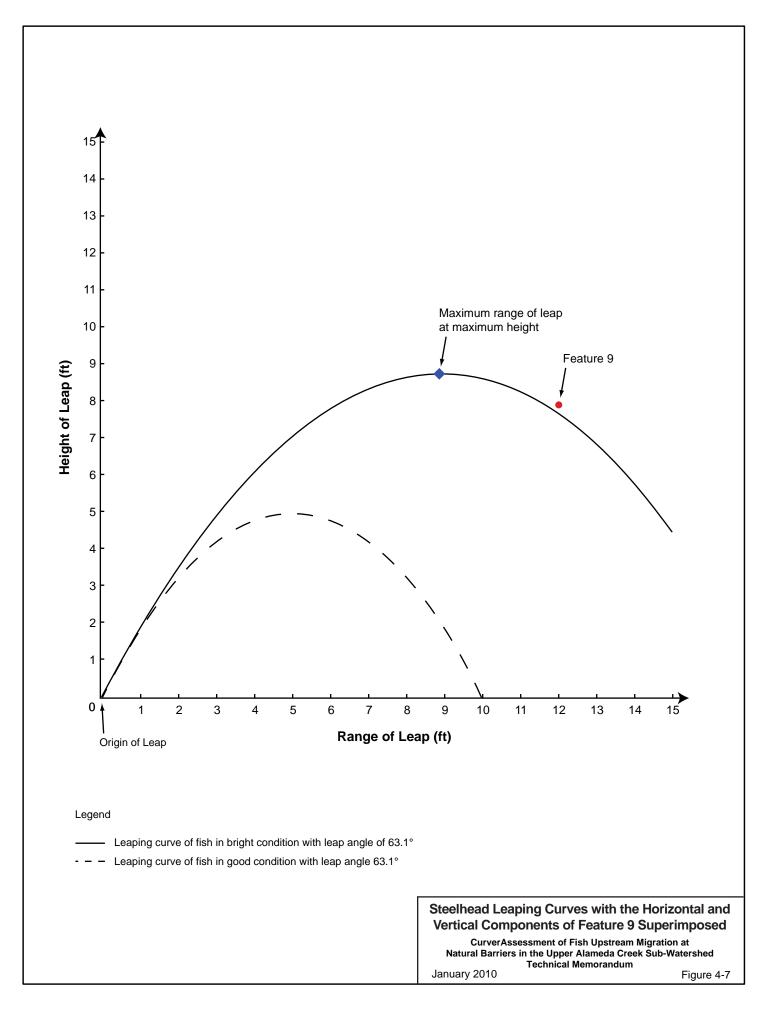
In summary, Feature 9 is determined to be impassable by bright steelhead during a flow of 2.5 cfs due to both its vertical height and horizontal range (Figure 4-6). Feature 9 was also determined to be impassable to steelhead in good condition (the condition expected of steelhead potentially immigrating to this feature in the future). The estimated maximum leap height of an adult steelhead in good condition (Cfc = 0.75) in Alameda Creek is 6.1 feet. The distance of the takeoff point from the falls (12.0 feet) reduces the vertical component of the fish's leap due to the reduced angle (63.1°) that the fish must leave the water. This angle reduces the height of the leap from its optimal 6.1 feet to 4.8 feet, and limits the horizontal distance of the leap to 8.8 feet (Figure 4-6). It is assumed that these distances would not be sufficient to negotiate passage by steelhead in good condition at this feature with flows observed during either the March 13 or June 23 field assessment.

Finally, it is noted that the landing at the top of the falls (Figure 4-8) is a chute (with a water depth of approximately 8 inches during the lower-flow field assessment) that would require the fish to achieve an adequate burst speed to reach a velocity refuge located approximately 3 feet upstream of the landing point. Figure 4-8 is a photograph taken from the top of the feature looking nearly straight down to show the narrow landing conditions, approximately one-half foot wide, at the top of the falls. It is uncertain if an adult steelhead (even in "bright" condition, Cfc = 1.00) would be able to achieve the level of precision required to navigate through this chute while descending through the air. The velocity of the chute and the distance to a velocity refuge upstream were determined not to be a limiting factor in the passability of this feature. It is unknown whether this feature poses a barrier to upstream migration at flows higher than 98 cfs (Section 5.1).

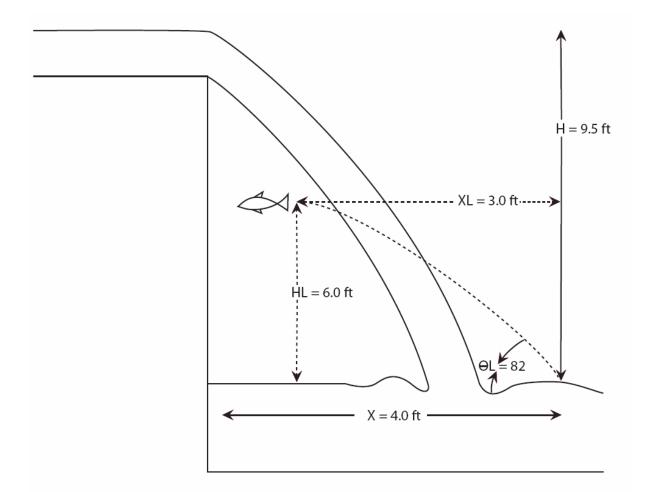
Figure 4-9

Feature 10 (Figure 4-9) is located approximately 200 feet from the upstream extent of Little Yosemite (Figure 4-1, Table 4-1).

Table 4-3Parameters Recorded at Feature 10 During a Creek Flow of 2.5 cfs			
Data           Parameter         Notation         Measured Value (feet)			
Vertical Height	Н	9.5	
Horizontal Width	X	4	
Depth of Staging Pool	dpp	_	
Depth of Landing Site	d <sub>c</sub>	0.4
